## STOUGHTON OUTDOOR FACILITIES AUDITS

*KMA audited the following municipal outdoor facilities:*

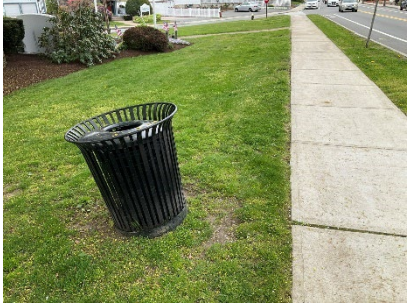
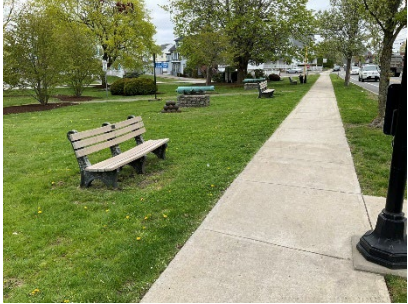
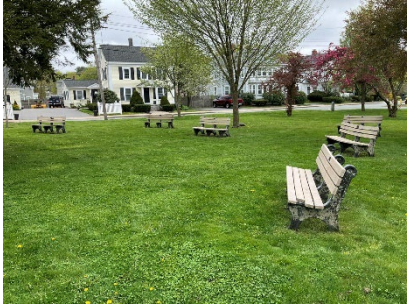
| # | Barrier Statement | Code References | Photo | Proposed Mitigation | Cost |
|---|---|---|---|---|---|
| 1. | <b>Site Amenities</b><br>The park benches and trash bin are not on an accessible route, due to the grass surface. | 2010 ADAS 206.1 | | Provide an accessible route to at least one of each type of site amenity. Consider benches serving gazebo performances as a unique type of bench.<br>Unit Cost: \$25/ SF<br>Est. Quantity: 1,000 SF | \$25,000 |

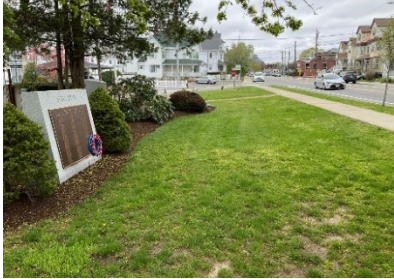
| 2. | <b>Memorial</b><br>There is no accessible route to the Honor Roll memorial facing Park Street. | 2010 ADAS 206.1 | | Provide an accessible route between the sidewalk and the memorial.<br>Unit Cost: \$25/SF<br>Est. Quantity: 200 SF | \$5,000 |

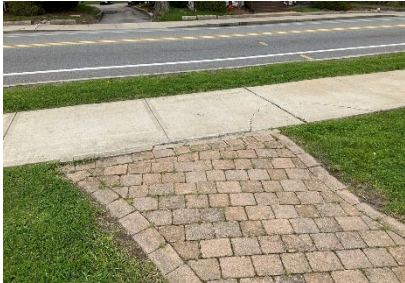
| 3. | <b>Walkway to Armed Forces Memorial</b><br>The walkway has a running slope >5%, @ up to 5.6% and has changes in level > ¼" along the sidewalk, @ 1". | 2010 ADAS 403.3 | | Regrade the walkway.<br>Unit Cost: \$25/SF<br>Est. Quantity: 100 SF | \$2,500 |

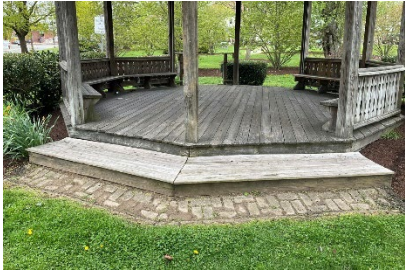
| 4. | <b>Gazebo</b><br>The gazebo is not on an accessible route, due to the grass surface.<br>The ramp to the gazebo has running slopes >8.3%, @ up to 8.9%, and has changes in level > ¼" at the bottom of the run, @ 1".<br>The stair to the gazebo lacks the required handrails on both sides. | 2010 ADAS 206.1<br>2010 ADAS 405.2<br>2010 ADAS 303.2<br>2010 ADAS 505.2 | <br> | Provide an accessible route between the sidewalk and the gazebo.<br>Unit Cost: \$25/SF<br>Est. Quantity: 600 SF<br>Rebuild the ramp.<br>Unit Cost: \$5,000 ea.<br>Quantity: 1<br>Install compliant handrails on both sides of the stairs.<br>Unit Cost: \$50/LF<br>Est. Quantity: 8 | \$20,400 |

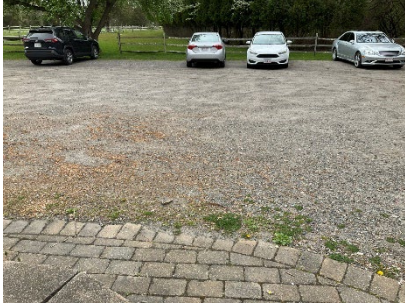
| # | Barrier Statement | Code References | Photo | Proposed Mitigation | Cost |
|---|---|---|---|---|---|
| 1. | <p><b>Parking</b></p> <p>The surface of the parking lot is not stable, firm, and slip resistant.</p> <p>There are no accessible parking spaces provided.</p> | <p>2010 ADAS 502.1</p> <p>2010 ADAS 502.4</p> | | <p>Pave and stripe a portion of the parking lot to add one van accessible parking space, including its associated sign and access aisle.</p> <p>Unit Cost: \$1,500 per space or aisle</p> <p>Quantity: 2 (1 space, 1 aisle)</p> | \$3,000 |

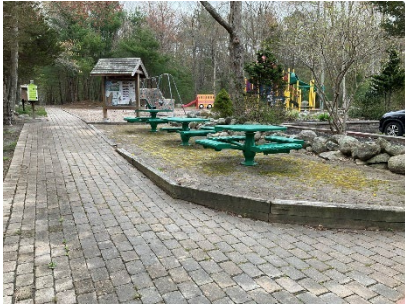
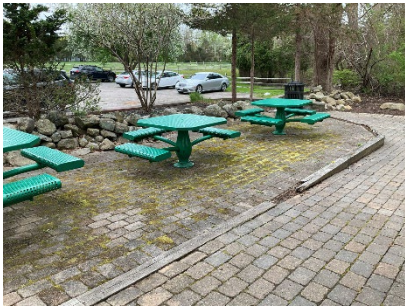
| # | Barrier Statement | Code References | Photo | Proposed Mitigation | Cost |
|---|---|---|---|---|---|
| 2. | <p><b>Walkway</b></p> <p>Both the walkway between the parking lot and the playground (not pictured) and walkway along the picnic tables have a running slope &gt;5%, @ up to 7.9%.</p> <p>The surface of the walkway leading to the accessible picnic table is not slip-resistant due to the moss.</p> | <p>2010 ADAS 403.3</p> <p>2010 ADAS 302.1</p> <p>ADA Title II Maintenance</p> | | <p>Regrade and ensure the maintenance of the walkways.</p> <p>Unit Cost: \$25/SF</p> <p>Est. Quantity: 500 SF</p> | \$12,500 |

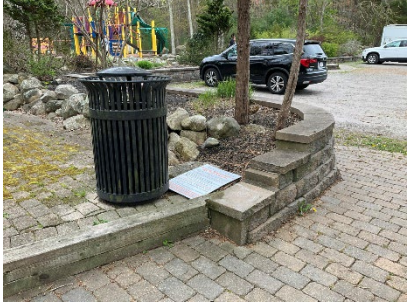
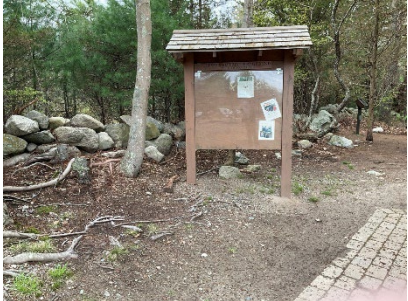
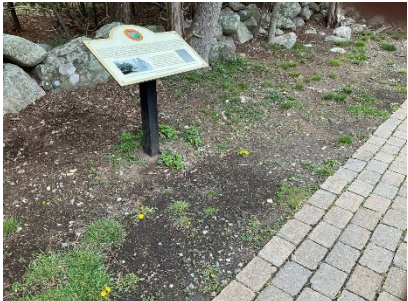
| 3. | <p><b>Site Amenities</b></p> <p>The trash bin and trail displays along the path leading to the trail are not on an accessible route, due to a step and the unpaved surface, respectively.</p> | 2010 ADAS 206.1 | | <p>Relocate the trash can to an accessible location and provide an accessible route to the trail displays.</p> <p>Unit Cost: \$25/ SF<br/>Est. Quantity: 100 SF</p> | \$2,500 |

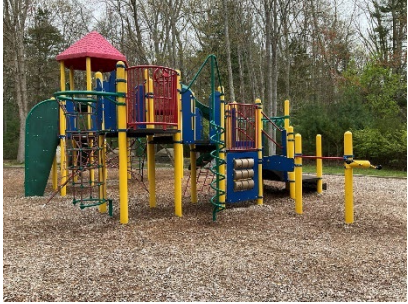
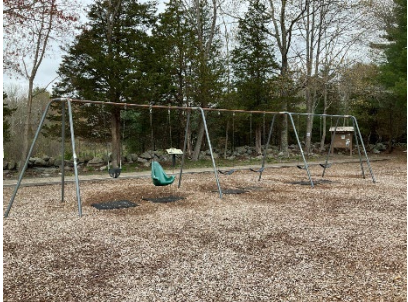
| 4. | <b>Play Surface</b><br>There is no accessible route to and within the playground area due to the wood fiber surface. | 2010 ADAS<br>1008.2.6 | | Resurface the playground.<br>Unit Cost: \$50,000<br>Quantity: 1 | \$50,000 |

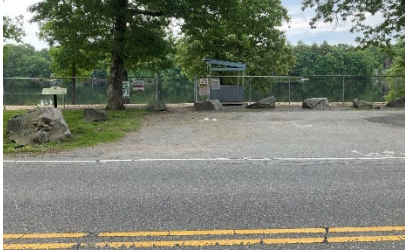
| # | Barrier Statement | Code References | Photo | Proposed Mitigation | Cost |
|---|---|---|---|---|---|
| 1. | <b>Parking</b><br>There are no accessible parking spaces provided on the parking lot serving the beach. For a lot with 1-25 spaces, one accessible space is required, and it must be van accessible. | 2010 ADAS 208 | | Pave and stripe a portion of the parking lot to add one van accessible parking space, including its associated sign and access aisle.<br>Unit Cost: \$1,500 per space or aisle<br>Quantity: 2 (1 space, 1 aisle) | \$3,000 |

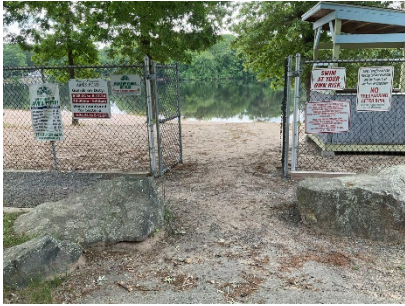
| # | Barrier Statement | Code References | Photo | Proposed Mitigation | Cost |
|---|---|---|---|---|---|
| 2. | <b>Walkway between Parking and Entry Gate</b><br>The walkway is not stable, firm or slip resistant due to areas of deterioration/material settlement. | 2010 ADAS 403.2 | | Regrade the walkway.<br>Unit Cost: \$25 SF<br>Est. Quantity: 50 SF | \$1,250 |

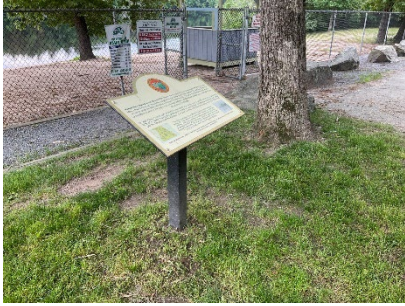
| # | Barrier Statement | Code References | Photo | Proposed Mitigation | Cost |
|---|---|---|---|---|---|
| 3. | <b>Display</b><br>The display exhibiting the history of the property is not along an accessible route due to the grass and gravel. | 2010 ADAS 206.1 | | Provide an accessible route to the display.<br>Unit Cost: \$25/SF<br>Est. Quantity: 50 SF | \$1,250 |

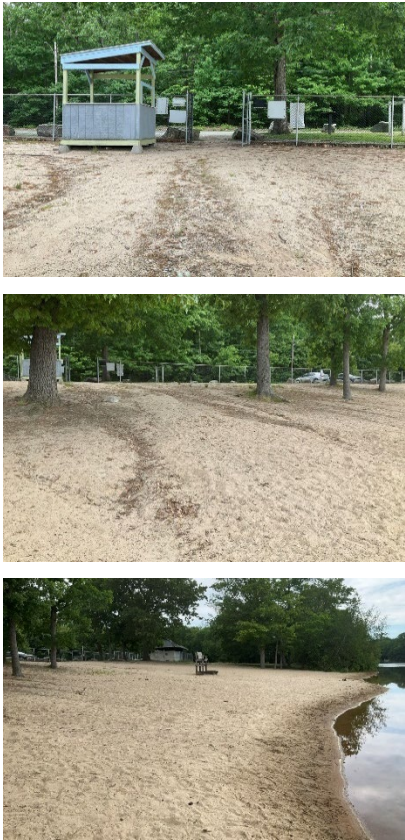
| 4. | <b>Beach Access</b><br><br>There is no accessible route to the water due to the surface condition and excessive slope. | 2010 ADAS 206.1 | | Provide an accessible route to the beach. Additional study required.<br>Unit Cost: \$25,000 ea.<br>Quantity: 1 | \$25,000 |

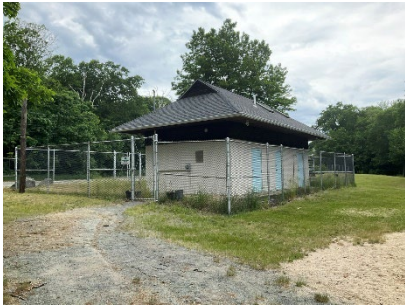
| 5. | <b>Outdoor Toilet Rooms</b><br><br>The toilet rooms located on the Western side of the building are not along an accessible route due to the sand, grass, and gravel.<br><br>Note: At the time of this audit, the toilet rooms were still locked for the off-season and were not audited. | 2010 ADAS 206.1 | | Provide an accessible route to the building, including the toilet rooms.<br>Unit Cost: \$25/SF<br>Est. Quantity: 1,000 SF | \$25,000 |

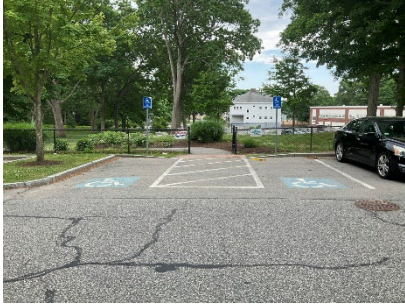
| # | Barrier Statement | Code References | Photo | Proposed Mitigation | Cost |
|---|---|---|---|---|---|
| 1. | <p><b>Parking</b></p> <p>The designated accessible parking spaces and their associated access aisles have slopes &gt;2%, @ up to 4%.</p> <p>The van parking space is &lt;96" wide, measured centerline to centerline, @ 92".</p> | 2010 ADAS 502 | | <p>Regrade and restripe the existing designated accessible parking spaces and their associated access aisle.</p> <p>Unit Cost: \$1,500 ea.</p> <p>Quantity: 2 (2 spaces, 1 aisle)</p> | \$3,000 |

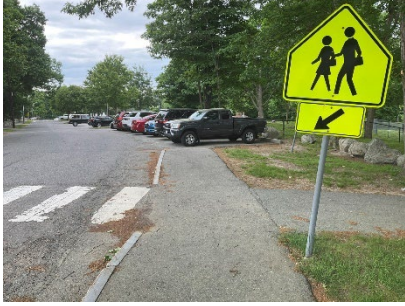
| # | Barrier Statement | Code References | Photo | Proposed Mitigation | Cost |
|---|---|---|---|---|---|
| 2. | <p><b>Sidewalk Near Parking</b></p> <p>There is no accessible route from the sidewalk about Pierce Street (and from Walnut Street) to the accessible entrance of the park because the sidewalk is interrupted by parking spaces.</p> | 2010 ADAS 206.1 | | <p>Provide an accessible route to the park.</p> <p>Unit Cost: \$25/SF</p> <p>Est. Quantity: 300 SF</p> | \$7,500 |

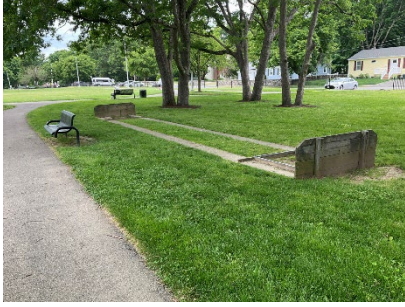
| # | Barrier Statement | Code References | Photo | Proposed Mitigation | Cost |
|---|---|---|---|---|---|
| 3. | <p><b>Bocce Court</b></p> <p>The bocce court is not along an accessible route due to the grass.</p> | 2010 ADAS 206.1 | | <p>Provide an accessible route to the park.</p> <p>Unit Cost: \$25/SF</p> <p>Est. Quantity: 80 SF</p> | \$2,000 |

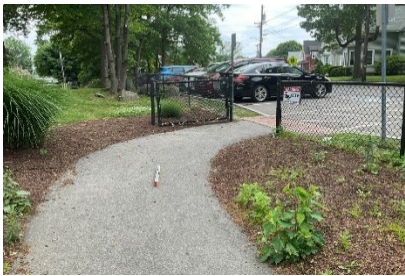
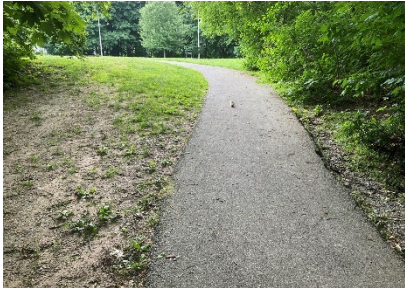
| 4. | <p><b>Asphalt Walkway (Throughout Park)</b></p> <p>The walkway throughout the park has multiple sections with running slopes &gt;5%, and are not treated as ramps:</p> <ul style="list-style-type: none"> <li>• @ up to 7.9%, near accessible parking spaces.</li> <li>• @ up to 5.3%, between school parking and playground.</li> <li>• @ up to 5.4%, near school parking lot.</li> <li>• @ up to 7.9%, between school parking and lawn.</li> <li>• @ up to 5.3%, near play components.</li> <li>• @ up to 7.5%, leading to the top of the slide.</li> </ul> | 2010 ADAS 403.3 | | <p>Regrade the walkways.</p> <p>Unit Cost: \$25/SF</p> <p>Est. Quantity: 480 SF</p> | \$12,000 |

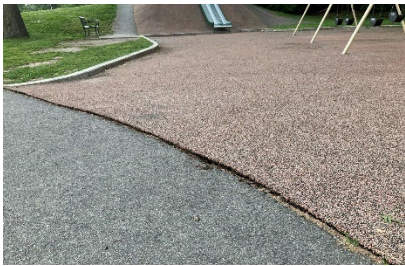
| 5. | <p><b>Play Surface</b></p> <p>There is a change in level &gt; 1/4" AFF at the intersection between the playground and the walking path, @ 1".</p> | 2010 ADAS 403.4 | | <p>Resurface the edge of playground.</p> <p>Unit Cost: \$1,000</p> <p>Quantity: 1</p> | \$1,000 |

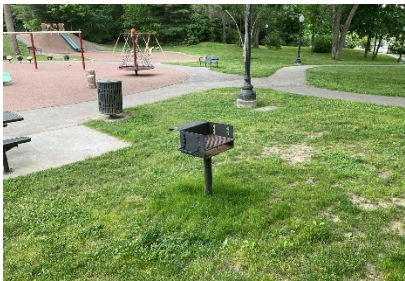
| 6. | <p><b>BBQ Pits</b></p> <p>The BBQ pit near the accessible picnic table is not along an accessible route due to the grass.</p> | 2010 ADAS 206.1 | | <p>Provide an accessible route to the BBQ pit.</p> <p>Unit Cost: \$25/SF</p> <p>Est. Quantity: 50 SF</p> | \$1,250 |

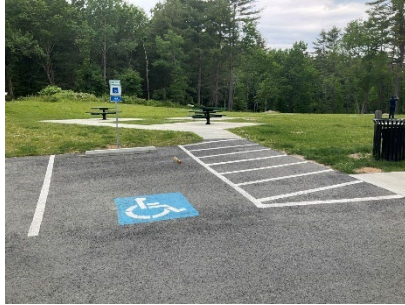
| GLEN ECHO PARK | | | | | |
|---|---|---|---|---|---|
| 1. | <p><b>Parking Near Picnic Tables</b></p> <p>The van accessible parking space and its associated access aisle have slopes &gt;2%, @ up to 7.4% adjacent to the walkway to the picnic tables.</p> <p>The accessible parking space signage is &lt;60" AFF measured to the bottom of the sign, @ 55".</p> <p>The van parking space is &lt;96" wide, measured centerline to centerline, @ 90" at the narrowest point.</p> | 2010 ADAS 502 | | <p>Regrade and restripe the existing designated accessible parking spaces and their associated access aisle.</p> <p>Unit Cost: \$1,500 ea.<br/>Quantity: 2 (1 space, 1 aisle)</p> <p>Install a van accessible sign at 60" AFF minimum, measured to the bottom of the sign.</p> <p>Unit Cost: \$100 ea.<br/>Quantity: 1</p> | \$3,100 |

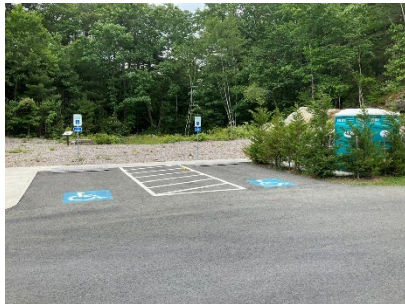
| GLEN ECHO PARK | | | | | |
|---|---|---|---|---|---|
| 2. | <p><b>Parking Near Picnic Tables</b></p> <p>The van accessible parking space and its associated access aisle have slopes &gt;2%, @ up to 3.1%.</p> <p>The accessible parking space signage is &lt;60" AFF measured to the bottom of the sign, @ 54".</p> | 2010 ADAS 502 | | <p>Regrade and restripe the existing designated accessible parking spaces and their associated access aisle.</p> <p>Unit Cost: \$1,500 ea.<br/>Quantity: 3 (2 spaces, 1 aisle)</p> <p>Install a van accessible sign at 60" AFF minimum, measured to the bottom of the sign.</p> <p>Unit Cost: \$100 ea.<br/>Quantity: 2</p> | \$4,700 |

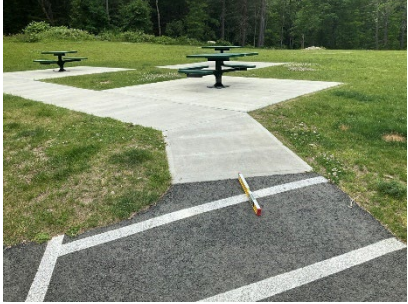
| 3. | <b>Walkway to Accessible Picnic Table</b><br><br>The walkway has running slopes >5%, @ up to 9.7% within the asphalt section and @ up to 6.2% within the concrete section and is not treated as ramps. | 2010 ADAS 403.3 | | Regrade the walkways.<br>Unit Cost: \$25/SF<br>Est. Quantity: 40 SF | \$1,000 |

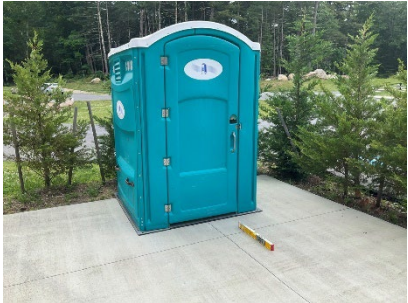
| 4. | <b>Portable Toilet</b><br><br>The door to the ADA-compliant, portable toilet lacks an exterior level landing ( $\leq 2\%$ ), @ 2.6%. | 2010 ADAS 404.2.4.4 | | Regrade the walkway.<br>Unit Cost: \$25/SF<br>Est. Quantity: 100 SF | \$2,500 |

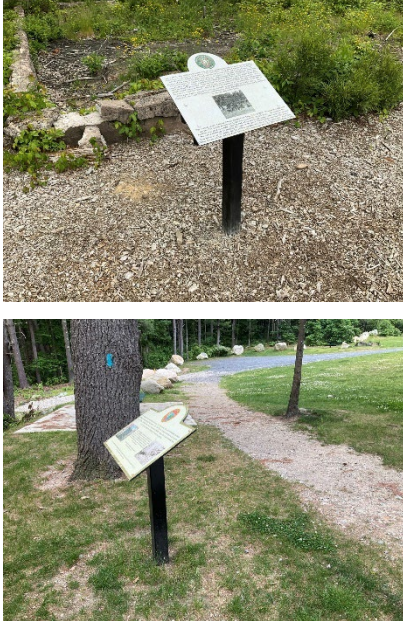
| 5. | <p><b>Displays</b></p> <p>The displays exhibiting the history of the property are not along an accessible route due to the grass, gravel, or mulch.</p> | 2010 ADAS 206.1 | | <p>Provide an accessible route to each display.</p> <p>Unit Cost: \$25/SF</p> <p>Est. Quantity: 400 SF</p> | \$10,000 |

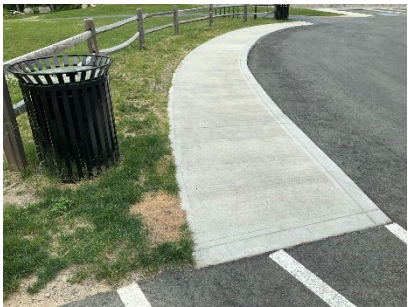
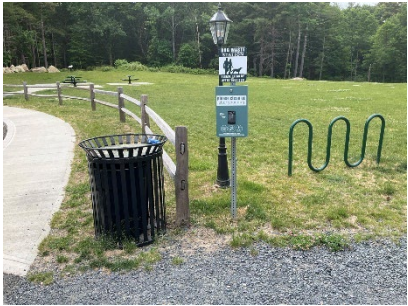
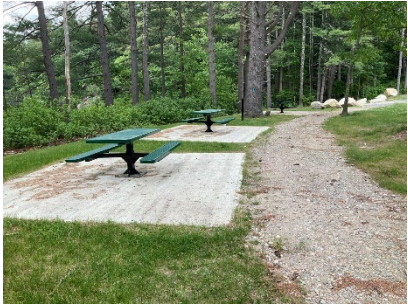
| 6. | <p><b>Site Amenities</b></p> <p>Some site amenities (i.e., picnic tables, trash cans, and dog waste bag receptacle) are not located along an accessible route due to the grass surface.</p> | 2010 ADAS 206.1 | | <p>Provide at least one of each type of amenity along an accessible route. Consider picnic tables along the water's edge as a unique type of picnic table.</p> <p>Unit Cost: \$25/SF<br/>Est. Quantity: 1,000 SF</p> | \$25,000 |

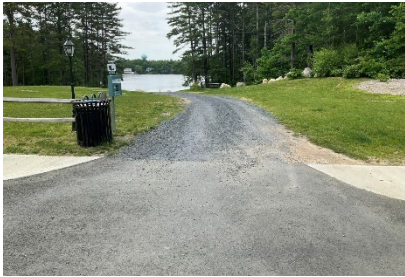
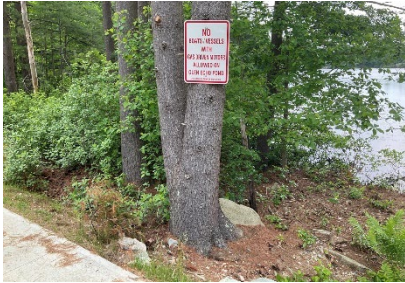
| 7. | <b>Boat Launch Ramp</b><br>An accessible boat launch ramp is not provided. | 2010 ADAS 206.2.10 | | Provide an accessible boat launch ramp.<br>Unit Cost: \$25/SF<br>Est. Quantity: 1,000 SF | \$25,000 |

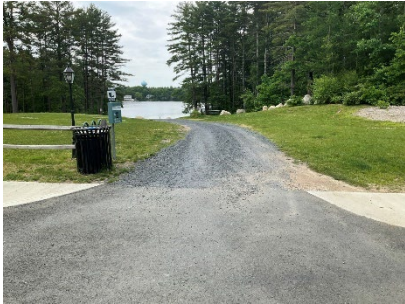
| 8. | <b>Trail</b><br>The hiking trail that loops between the parking lot, the boat launch ramp, and through the woods is not accessible due to the gravel surface. | 2010 ADAS 206.1 | | Provide an accessible route along the hiking trail.<br>Unit Cost: \$25/SF<br>Est. Quantity: 3,000 SF | \$75,000 |

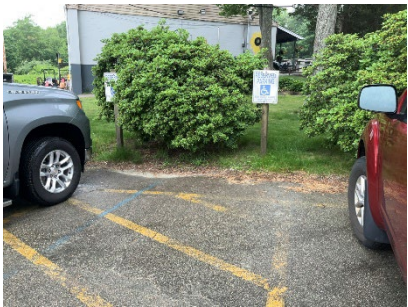
| # | Barrier Statement | Code References | Photo | Proposed Mitigation | Cost |
|---|---|---|---|---|---|
| 1. | <p><b>Parking</b></p> <p>The designated accessible parking spaces and their associated access aisles have slopes &gt;2%, @ up to 6%.</p> <p>In addition, the signs for these parking spaces are mounted &lt;60", @ 38" measured to the bottom of the sign.</p> | 2010 ADAS 502 | | <p>Regrade and restripe the existing designated parking spaces and their associated access aisles.</p> <p>Unit Cost: \$1,500 ea.<br/>Quantity: 3 (2 spaces + 1 aisle)</p> <p>Install signs at 60" min. AFF, measured to the bottom of the sign.</p> <p>Unit Cost: \$100 ea.<br/>Quantity: 2</p> | \$4,700 |

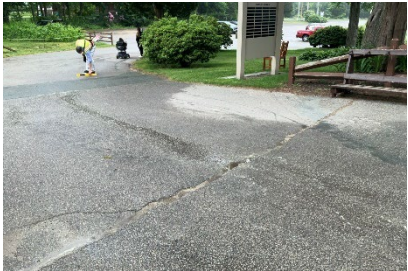
| # | Barrier Statement | Code References | Photo | Proposed Mitigation | Cost |
|---|---|---|---|---|---|
| 2. | <p><b>Accessible Route</b></p> <p>The walkway from the accessible parking spaces to building entrance and golf course has slopes &gt;8.3%, @ up to 9.2%. In addition, the ground surface is not stable, firm, or slip resistant with changes in level &gt; 1/2" due to material deterioration.</p> | 2010 ADAS 403 | | <p>Regrade the walkway.</p> <p>Unit Cost: \$25/SF<br/>Est. Quantity: 400 SF</p> | \$10,000 |

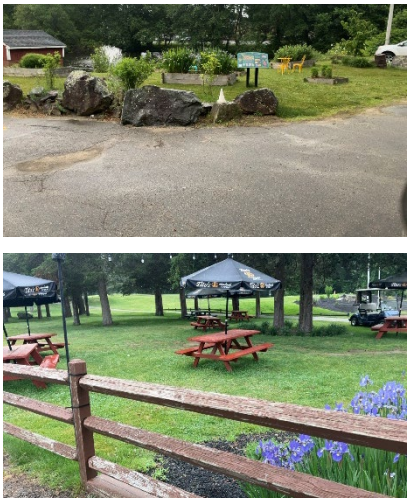
| 3. | <p><b>Site Amenities</b></p> <p>Some site amenities (i.e., picnic tables, gardens) are not located along an accessible route due to the grass surface.</p> | 2010 ADAS 206 | | <p>Provide an accessible picnic table with the required clearance for a forward approach along an accessible route.<br/>Unit Cost: \$250 ea.<br/>Est. Quantity: 1</p> <p>Provide an accessible route to the gardens.<br/>Unit Cost: \$25/SF<br/>Est. Quantity: 60 SF</p> | \$1,750 |

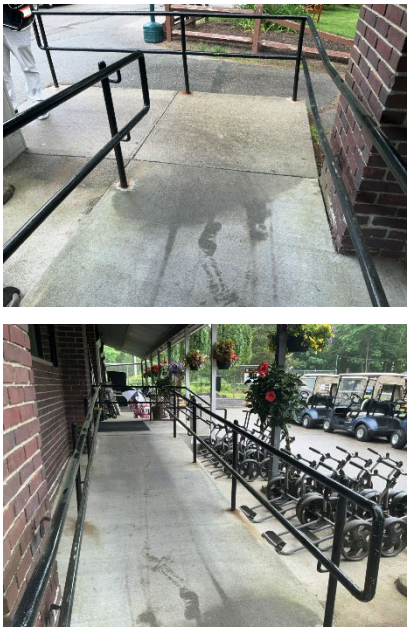
| 4. | <p><b>Exterior Ramp</b></p> <p>At the bottom of the top section of ramp to the main entrance has slopes &gt;8.3%, @ up to 8.8%.</p> <p>The ramp is &lt;48" wide, @ 44".</p> <p>The ramp lacks edge protection on one side.</p> | 2010 ADAS 405 | | <p>Rebuild the ramp.<br/>Unit Cost: \$15,000 ea.<br/>Est. Quantity: 1</p> | \$15,000 |

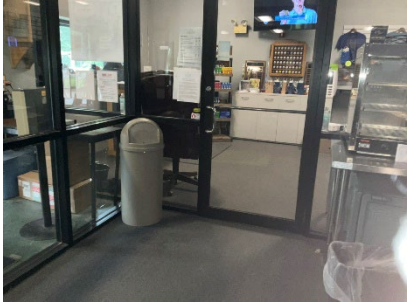
| 5. | <p><b>Pro Shop</b></p> <p>The height of the counter surface measured &gt;36", @ 42".</p> <p>The door maneuvering clearance on pull side obstructed by a trash can.</p> | <p>2010 ADAS 902</p> <p>ADA Title II Maintenance</p> | | <p>Lower a 36" wide portion of the counter to 36" max. AFF.</p> <p>Unit Cost: \$750 ea.</p> <p>Quantity: 1</p> <p>Relocate the trash can.</p> <p>Unit Cost: \$50 ea.</p> <p>Quantity: 1</p> | \$800 |

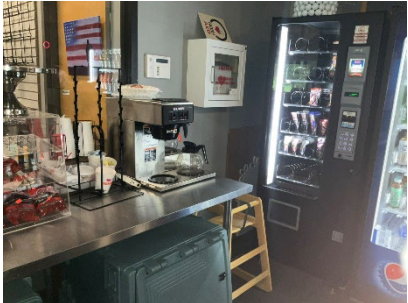
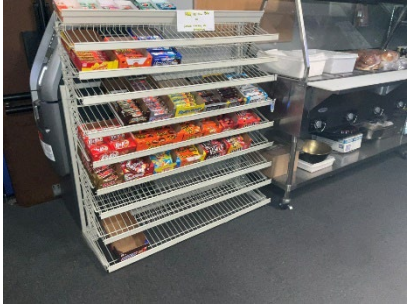
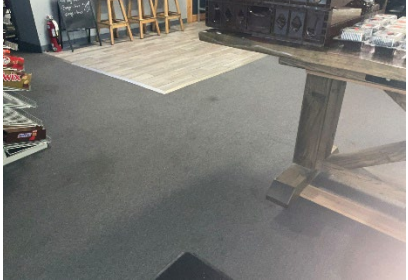
| 6. | <p><b>Entrance Lobby</b></p> <p>The topmost control at the AED box is mounted &gt;48" AFF, @ 58".</p> <p>The top rack at the snack station measured &gt;48" AFF, @ 51".</p> <p>The edge of the high wooden table protrudes &gt;4" into the circulation space.</p> | <p>2010 ADAS 308</p> <p>2010 ADAS 307.1</p> | | <p>Lower the AED box.</p> <p>Unit Cost: \$50 ea.</p> <p>Quantity: 1</p> <p>Provide a complaint candy rack.</p> <p>Unit Cost: \$150 ea.</p> <p>Quantity: 1</p> <p>Relocate the table.</p> <p>Unit Cost: \$50 ea.</p> <p>Quantity: 1</p> | \$250 |

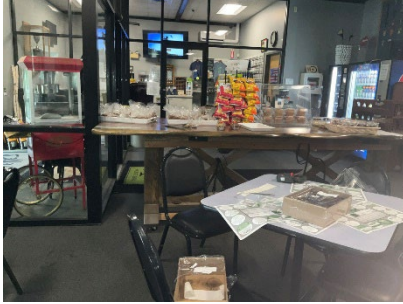
| 7. | <b>Restaurant/Bar</b><br><br>The height of the bar counter measured >34".<br><br>There are no accessible tables due to their pedestal base. | 2010 ADAS 902 | | Lower a 36" wide portion of the counter to 36" max. AFF.<br><br>Unit Cost: \$750 ea.<br>Quantity: 1<br><br>Provide at least one accessible table.<br>Unit Cost: \$250 ea.<br>Est. Quantity: 1 | \$1,000 |

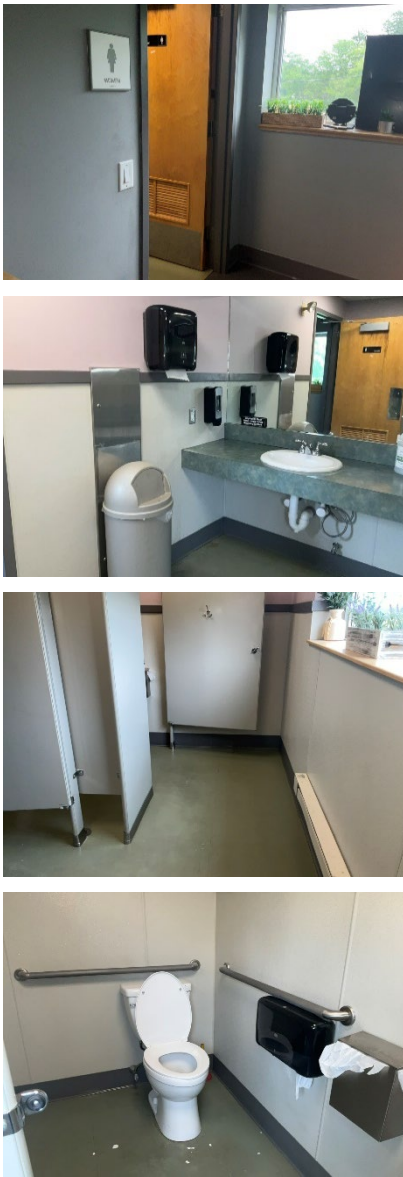
| <p>8.</p> | <p><b>Toilet Rooms (Men's &amp; Women's)</b></p> <p>The entry door requires more than 5lbs of force to operate.</p> <p>The lavatory is mounted &gt;34" AFF, @ up to 34 ¾".</p> <p>The paper towel dispenser is mounted &gt;48" AFF, @ 56".</p> <p>The self-closing hinge on the accessible stall door is faulty.</p> <p>The side grab bar extends &lt;54", @ up to 50" measured from the rear wall.</p> <p>The toilet paper dispenser is mounted &lt; 1 ½" below the side wall grab bar.</p> <p>The coat hook is mounted &gt;48" AFF, @ up to 53".</p> <p>The accessible stall door maneuvering clearance on the latch pull side for a side approach measured &lt;42" @ 40 ½" measured to the face of the heater. In addition, the door is not located maximum 4" from the side partition farthest from the toilet (Women's only).</p> <p>The entry door provides &lt;32" of clear width due to the door being unable to open 90 degrees (Men's only).</p> <p>The toilet centerline measured &gt;16"-18", @ 18 ½" measured from the sidewall (Men's only).</p> | <p>2010 ADAS 404</p> <p>2010 ADAS 606</p> <p>2010 ADAS 307</p> <p>2010 ADAS 604</p> <p>2010 ADAS 609</p> | | <p>Adjust the door closer.<br/>Unit Cost: \$50 ea.<br/>Quantity: 2</p> <p>Lower the lavatory.<br/>Unit Cost: \$750 ea.<br/>Quantity: 2</p> <p>Relocate the dispenser.<br/>Unit Cost: \$50 ea.<br/>Quantity: 2</p> <p>Fix the self-closing hinge on the accessible stall door.<br/>Unit Cost: \$100 ea.<br/>Quantity: 2</p> <p>Relocate the side wall grab bar.<br/>Unit Cost: \$50 ea.<br/>Quantity: 2</p> <p>Lower the toilet paper dispenser.<br/>Unit Cost: \$50 ea.<br/>Quantity: 2</p> <p>Lower the coat hook.<br/>Unit Cost: \$50 ea.<br/>Quantity: 2</p> <p>Reposition the stall partition.<br/>Unit Cost: \$500 ea.<br/>Quantity: 1</p> <p>Fix the swing of the door to allow for an opening of 90 degrees.<br/>Unit Cost: \$500 ea.<br/>Quantity: 1</p> <p>Reposition the flush valve or install an automatic flush control.<br/>Unit Cost: \$1,500 ea.<br/>Quantity: 1</p> | <p>\$4,700</p> |

| | The flush valve is not located on the open side of the toilet (Men's only). | | | | |

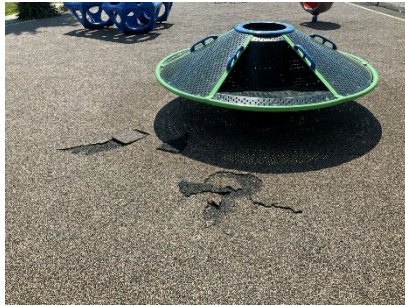
| LEVITZ PLAYGROUND | | | | | |
|---|---|---|---|---|---|
| 1. | <b>Play Surface</b><br>There is a change in level > ¼" AFF where the playground surface is deteriorated, @ 1". | 2010 ADAS 403.4 | | Resurface the deteriorated section of playground.<br>Unit Cost: \$500<br>Quantity: 1 | \$500 |

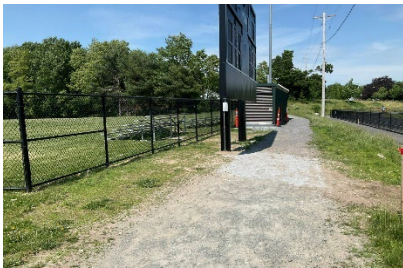
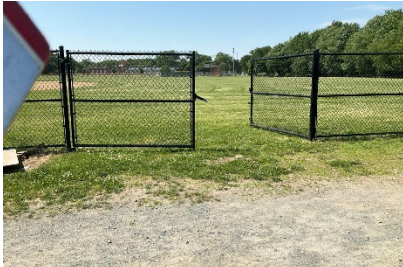
| 1. | <p><b>Walkways</b></p> <p>The walkway that loops around the complex and along Levitz Playground is not accessible due to the gravel and stone dust surface.</p> <p>Further, the walkway is &lt;36" wide in certain areas along the East side of the complex.</p> | 2010 ADAS 206.1 | | <p>Provide an accessible route throughout the complex.</p> <p>Unit Cost: \$25/SF</p> <p>Est. Quantity: 2,800 SF</p> | \$70,000 |

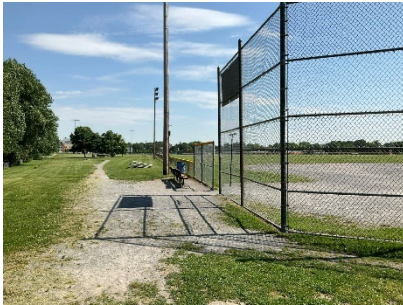
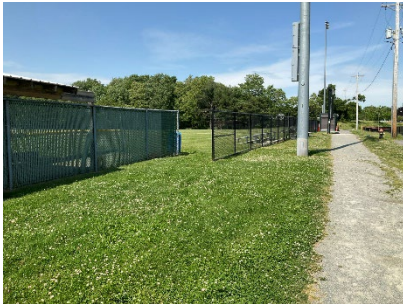
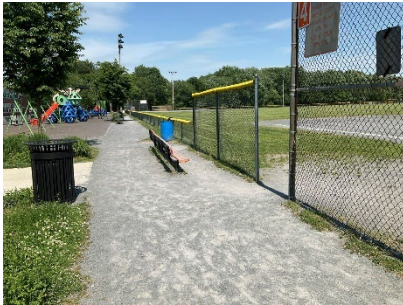
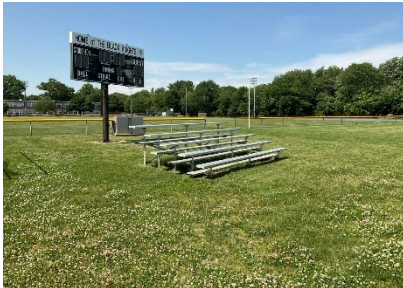
| 2. | <p><b>Sports Fields</b></p> <p>None of sports fields provide an accessible route connecting elements and spaces within areas of sports activities, including an:</p> <ul style="list-style-type: none"> <li>• Accessible route from the looping walkway to the field.</li> <li>• Accessible route to team player seating areas (i.e., dugouts on baseball fields and team benches along the sidelines of the soccer field).</li> <li>• Accessible route to spectator seating (i.e., benches and bleachers), when provided.</li> </ul> | 2010 ADAS 206.1 | | <p>Provide at least one of each type of sports fields along an accessible route, including an accessible route to all of the field's elements and spaces within areas of sports activities. For bleachers, provide the required number of wheelchair spaces and at least one companion seat per wheelchair space.</p> <p>Unit Cost: \$25/SF<br/>Est. Quantity: 600 SF</p> | \$15,000 |

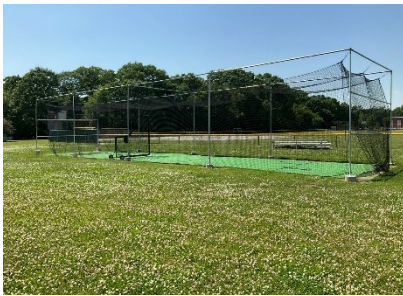
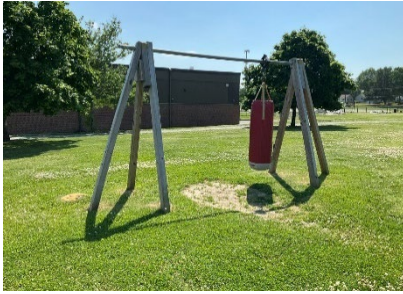
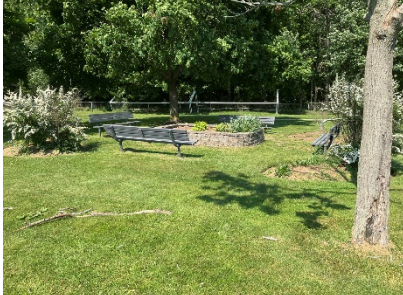
| 3. | <p><b>Site Amenities</b></p> <p>Some site amenities (i.e., batting cages, punching bag, and benches) are not located along an accessible route due to the grass surface.</p> | <p>2010 ADAS<br/>206.2.1</p> | | <p>Provide at least one of each type of amenity along an accessible route.</p> <p>Unit Cost: \$25/SF<br/>Est. Quantity: 700 SF</p> | <p>\$17,500</p> |

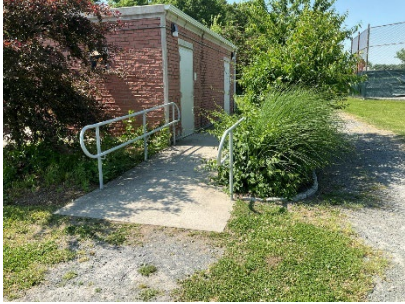
| 4. | <p><b>Exterior Ramps</b></p> <p>Both ramps leading to the toilet rooms lack a level landing and have handrails that do not extend the length on their run. Further, the ramps are not located on an accessible route due to the gravel surface.</p> <p>Further, the ramp handrails are obstructed by the vegetation.</p> | 2010 ADAS 405 | | <p>Rebuild the ramps.<br/>Unit Cost: \$5,000 ea.<br/>Quantity: 2</p> <p>Provide an accessible route to the ramp.<br/>Unit Cost: \$25/SF<br/>Est. Quantity: 40 SF</p> | \$11,000 |

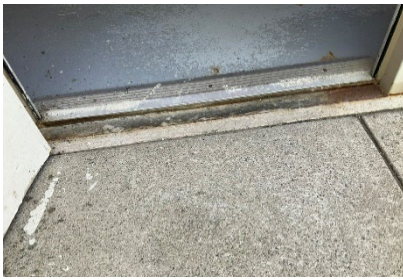
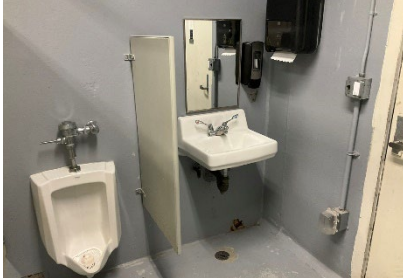
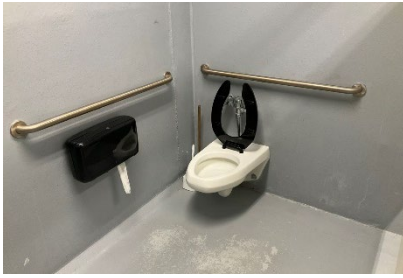
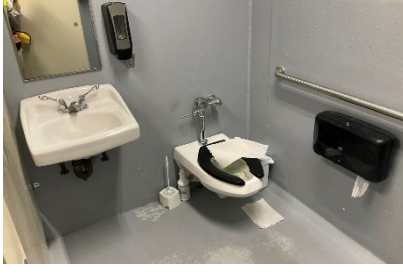
| <p>5.</p> | <p><b>Toilet Rooms (Men's &amp; Women's)</b></p> <p>The threshold is &gt; 1/2", @ 3/4" and is not beveled.</p> <p>The bottom of the reflective surface of the mirror is &gt;40" AFF, @ 48" (Women's only).</p> <p>The pipes underneath the lavatory are not insulated (Men's only).</p> <p>The paper towel dispenser is mounted &gt;48" AFF, @ 54" (Men's only).</p> <p>The coat hook is &gt;54" AFF, @ 57" (Men's only).</p> <p>The grab bars are not mounted 33"-36" AFF, @ 37", measured to the top of the gripping surface.</p> <p>The toilet lacks the required clearance around it due to the lavatory and soap dispenser inside the accessible toilet stall (Women's only).</p> <p>The self-closing hinge on the accessible stall door is faulty.</p> | <p>2010 ADAS 404</p> <p>2010 ADAS 606</p> <p>2010 ADAS 308</p> <p>2010 ADAS 603</p> <p>2010 ADAS 604</p> <p>2010 ADAS 609</p> | | <p>Replace the threshold.<br/>Unit Cost: \$250<br/>Quantity: 2</p> <p>Lower the mirror.<br/>Unit cost: \$50 ea.<br/>Quantity: 2</p> <p>Insulate the pipes underneath the sink.<br/>Unit Cost: \$50 ea.<br/>Quantity: 1</p> <p>Relocate the paper towel dispenser.<br/>Unit Cost: \$50 ea.<br/>Quantity: 1</p> <p>Relocate the grab bars.<br/>Unit cost: \$50 ea.<br/>Quantity: 4</p> <p>Remove the lavatory and soap dispenser inside the accessible toilet stall.<br/>Unit cost: \$500 ea.<br/>Quantity: 1</p> <p>Lower the coat hook.<br/>Unit Cost: \$50 ea.<br/>Quantity: 1</p> <p>Install a self-closing door.<br/>Unit Cost: \$150 ea.<br/>Quantity: 2</p> | <p>\$1,750</p> |
