## STOUGHTON BUILDING AUDITS

*KMA audited the following municipal buildings:*

## TOWN HALL

*AUDITED ON: MAY 1, 2024*

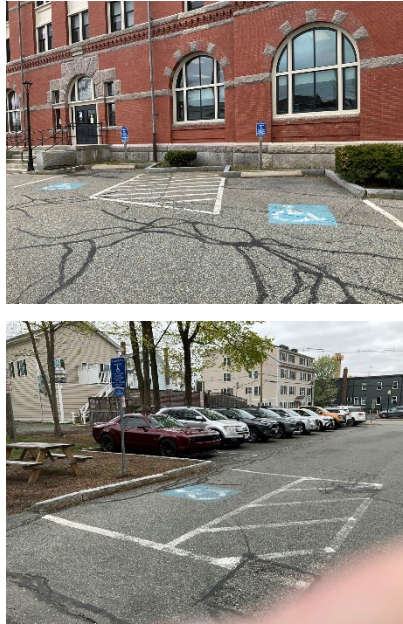
| # | Barrier Statement | Code References | Photo | Proposed Mitigation | Cost |
|---|---|---|---|---|---|
| 1. | <p><b>Parking</b></p> <p>The accessible parking spaces near the main entrance have slopes &gt;2%, @ up to 6%.</p> <p>The accessible parking space signage is &lt;60" AFF measured to the bottom of the signs.</p> <p>The surface of the accessible parking spaces is deteriorated and cracked, creating an unstable surface.</p> <p>The van accessible access aisle on the employee parking lot is &lt;96" wide @ 60", measured centerline to centerline.</p> | <p>ADAS 502.4</p> <p>ADAS 502.6</p> | | <p>Regrade and restripe the existing designated parking spaces and their associated access aisles.</p> <p>Unit Cost: \$1,500 ea.</p> <p>Quantity: 3 (2 spaces, 1 aisle)</p> <p>Install a sign with the International Symbol of Accessibility at 60" AFF minimum, measured to the bottom of the sign. Include a van accessible sign where applicable.</p> <p>Unit Cost: \$100 ea.</p> <p>Quantity: 2</p> | \$3,200 |

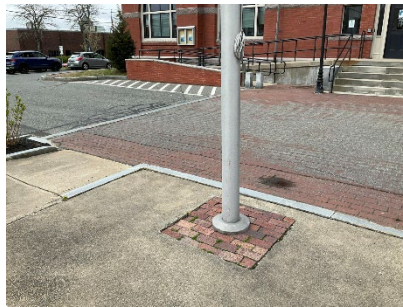
| # | Barrier Statement | Code References | Photo | Proposed Mitigation | Cost |
|---|---|---|---|---|---|
| 2. | <p><b>Flagpole</b></p> <p>The walkway around the flagpole has abrupt changes of levels because of material settlement and deterioration.</p> <p>The rope hook is mounted &gt;48" AFF, @ 60".</p> | <p>2010 ADAS 403.4</p> <p>2010 ADAS 308</p> | | <p>Regrade the brick surface around the flagpole.</p> <p>Unit cost: \$25/SF</p> <p>Est. Quantity: 8 SF</p> <p>Relocate the rope hook.</p> <p>Unit Cost: \$250 ea.</p> <p>Quantity: 1</p> | \$450 |

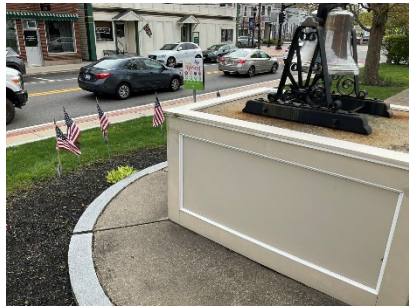
| 3. | <b>Memorial</b><br>There is no accessible route to all sides of the memorial, including the memorial plaque facing Pearl Street. | 2010 ADAS 206.1 | | Provide an accessible route to the memorial. Additional study required.<br>Unit Cost: \$5,000 ea.<br>Quantity: 1 | \$5,000 |

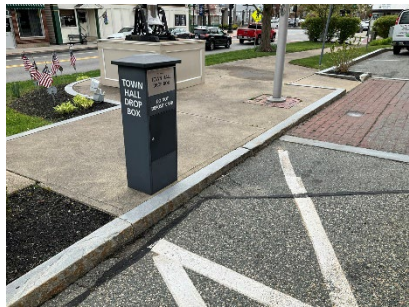
| 4. | <b>Drop Box</b><br>The afterhours drop box is not located on an accessible route due to the curb and has a cross slopes >2%, @ up to 5%. | 2010 ADAS 206.1 | | Relocate the drop box to an accessible location.<br>Unit Cost: \$250<br>Quantity: 1 | \$250 |

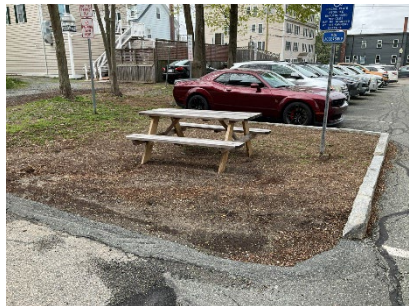
| 5. | <b>Picnic Table</b><br>The table lacks the required knee and toe clearance, clear floor space, and is not on an accessible route due to the mulch surface. | 2010 ADAS 206.1<br>2010 ADAS 305.2<br>2010 ADAS 902.4.1 | | Provide an accessible picnic table located on an accessible route.<br>Unit Cost: \$250 ea.<br>Quantity: 1 | \$250 |

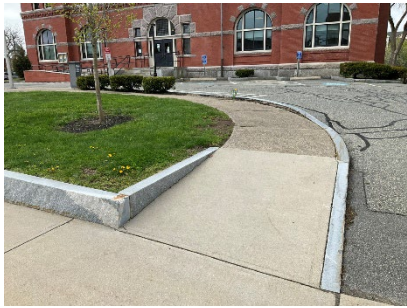
| 6. | <p><b>Exterior Accessible Route</b></p> <p>The walkway between Pearl Street and the main entrance has running slopes &gt;5%, @ up to 13%.<br/>The walkway has cross slopes &gt;2%, @ up to 3%.</p> | <p>2010 ADAS 302.1<br/>2010 ADAS 403.3</p> | | <p>Regrade the walkway.<br/>Unit Cost: \$25/SF<br/>Est. Quantity: 100 SF</p> | <p>\$2,500</p> |

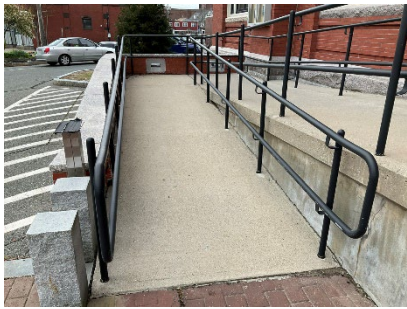
| 7. | <p><b>Ramp to Front Entrance (East Side)</b></p> <p>The lower landing of the ramp has a slope &gt;2%, @ 2.7%.<br/>The lower ramp has running slopes &gt;8.3% @ up to 9.7%.<br/>The intermediate landing of the ramp has a width &gt;60", @ 55".</p> | <p>2010 ADAS 502.2</p> | | <p>Rebuild the ramp.<br/>Unit Cost: \$15,000 ea.<br/>Quantity: 1</p> | <p>\$15,000</p> |

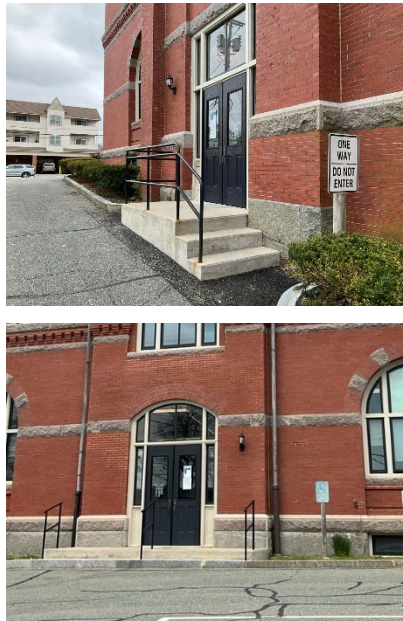
| 8. | <p><b>Side Entrances (North/South Sides)</b></p> <p>The entrances are not accessible due to the step.</p> <p>The stairs lack the required handrails on both sides.</p> | <p>2010 ADAS 505.2</p> <p>2010 ADAS 216.6</p> | | <p>Install signage at all non-accessible entrances indicating the nearest accessible entrance/exit.</p> <p>Unit Cost: \$150 ea.</p> <p>Quantity: 2</p> <p>Install compliant handrails on both sides of the stairs.</p> <p>Unit Cost: \$50/LF</p> <p>Est. Quantity: 16 LF</p> | \$1,100 |

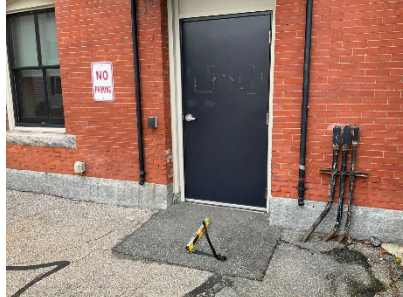
| 9. | <p><b>Rear Entrance (West Side)</b></p> <p>The entrance door is located in a recess &gt;8" and lacks a level landing, @ 7.1%.</p> | <p>2010 ADAS 404.2.4.3</p> <p>2010 ADAS 404.2.4.4</p> | | <p>Regrade the door landing.</p> <p>Unit Cost: \$1,000</p> <p>Quantity: 1</p> <p>Install an automatic door opener.</p> <p>Unit Cost: \$2,500 ea.</p> <p>Quantity: 1</p> | \$3,500 |

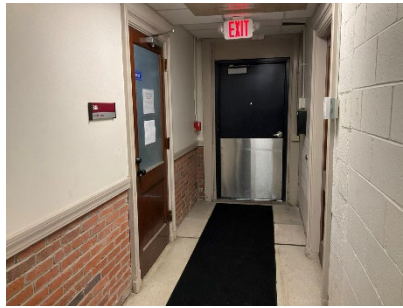
| 10. | <p><b>At-grade Egress Door (Basement)</b></p> <p>The threshold is <math>&gt;1/2''</math> high at the entrance door, @ <math>1''</math>.</p> <p>The door maneuvering clearance is <math>&lt;12''</math> on the latch, push side for a front approach, @ <math>9''</math>.</p> | <p>2010 ADAS 404.2.5</p> <p>2010 ADAS 404.2.4.1</p> | | <p>Replace the threshold.</p> <p>Unit Cost: \$250 ea.</p> <p>Quantity: 1</p> <p><i>See remediation for automatic door opener on item above.</i></p> | \$250 |

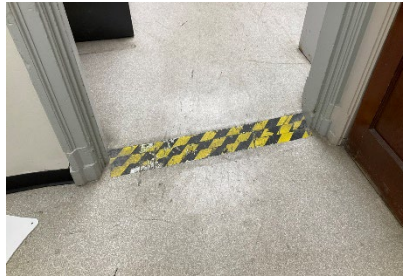
| 11. | <p><b>Interior Accessible Route</b></p> <p>The floor transition strip of the vestibule door on the first floor is not beveled at 1:2.</p> <p>The doorway to the elevator lobby on the basement level has a running slope <math>&gt;5\%</math>, @ <math>18.9\%</math>.</p> <p>The walkway within the basement hall has running slopes <math>&gt;5\%</math>, @ <math>8.6\%</math>.</p> | <p>2010 ADAS 303.2</p> <p>2010 ADAS 403.3</p> | <br><br> | <p>Replace the transition strip.</p> <p>Unit Cost: \$250 ea.</p> <p>Quantity: 1</p> <p>Regrade the flooring adjacent to the doorway.</p> <p>Unit Cost: \$2,500 ea.</p> <p>Quantity: 1</p> <p>Regrade the flooring within the basement hall.</p> <p>Unit Cost: \$5,000 ea.</p> <p>Quantity: 1</p> | \$7,750 |

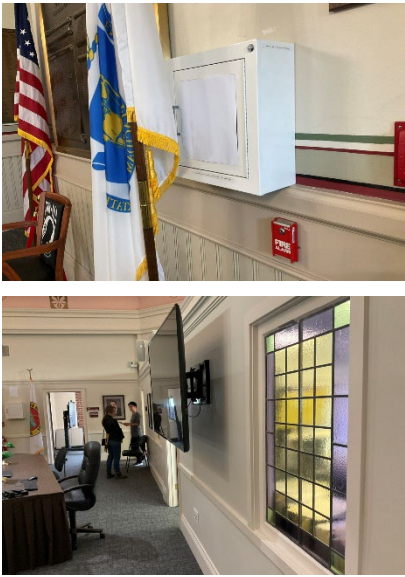
| 12. | <p><b>Protruding Objects</b></p> <p>The wall-mounted cabinet in the lobby of the first floor protrudes &gt;4" into the circulation space, @ 4.5".</p> <p>The televisions protrude &gt;4" into the circulation area in the Great Hall on the third floor, @ up to 12".</p> | 2010 ADAS 307.2 | | <p>Install a cane detectable object below the box.<br/>Unit Cost: \$250 ea.<br/>Quantity: 1</p> <p>Install a cane detectable object below the televisions.<br/>Unit Cost: \$250 ea.<br/>Quantity: 2</p> | \$750 |

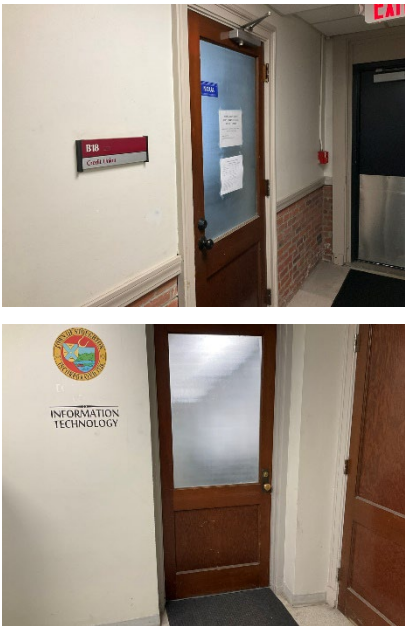
| 13. | <p><b>Door Hardware (Typical)</b></p> <p>The door hardware of the Credit Union and IT Department on the basement level require tight grasping, pinching, or twisting of the wrist to operate.</p> | 2010 ADAS 404.2.7 | | <p>Replace the door hardware with lever types.<br/>Unit Cost: \$300<br/>Quantity: 2</p> | \$600 |

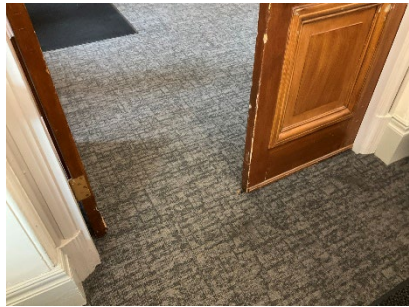
| 14. | <b>Door Width (Typical)</b><br><p>The doors to the Assessor's Office, Tax Collector, and HR/Payroll on the first floor provides &lt;32" clear width, @ 28 1/4".</p> | 2010 ADAS 404.2.3 | | <p>Replace the doors with off-set doors and a wider door leaf.<br/> Unit Cost: \$1,000<br/> Quantity: 3</p> | \$3,000 |

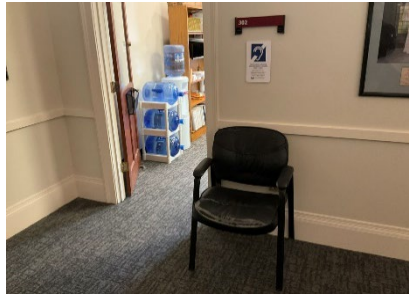
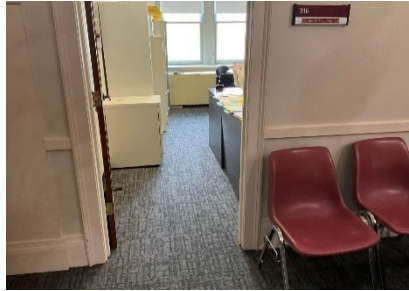
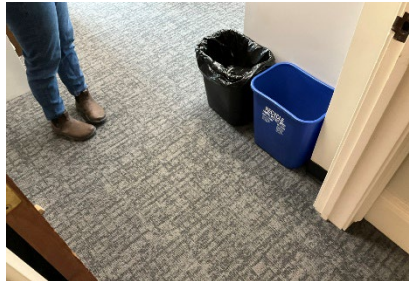
| 15. | <b>Door Maneuvering Clearances (Typical)</b><br><p>The maneuvering clearance at the doors to the Public Access Office and Economy Development are &lt;12" on the latch, pull side for a front approach, obstructed by a chair.</p> <p>The maneuvering clearance at the doors to Economic Development and Town Accountant are &lt;18" on the latch pull-side, obstructed by the counter and trash cans/file cabinet, respectively.</p> | 2010 ADAS 404.2.4 | <br><br> | <p>Install an automatic door opener.<br/> Unit Cost: \$2,500 ea.<br/> Quantity: 2</p> <p>Relocate the furniture.<br/> Unit Cost: \$50 ea.<br/> Quantity: 2</p> | \$5,100 |

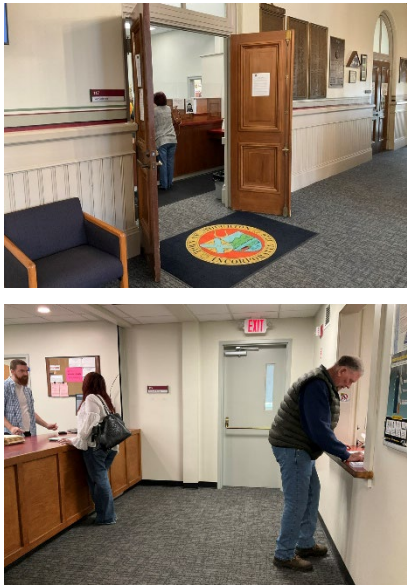
| 16. | <b>Counters (Typical)</b><br>The counters serving the Tax Collector and Clerk's Office on the first floor and the Visiting Nurse Office and Engineering Department on the second floor are >36" AFF, @ 44 1/4" | 2010 ADAS 904.4 | | Lower a 36" wide portion of the counter to 36" max. AFF.<br>Unit Cost: \$3,000 ea.<br>Quantity: 4 | \$12,000 |

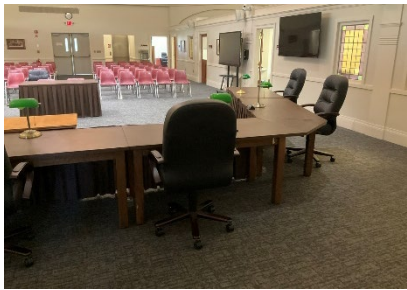
| 17. | <b>Desks in Great Hall (Third Floor)</b><br>The knee clearance at the desk is <27" AFF, @ 26". | 2010 ADAS 306.2 & 306.3 | | Provide at least one desk, and no less than 5% of the total number, with compliant knee and toe clearances.<br>Unit Cost: \$250<br>Quantity: 1 | \$250 |

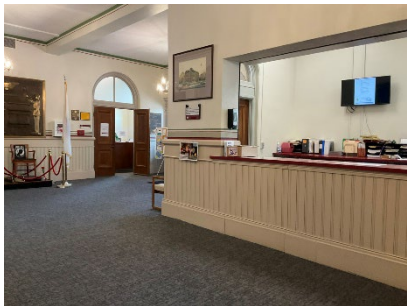
| 18. | <b>Hand Sanitizer</b><br>The hand sanitizer near the Clerk's Office is >48" AFF, @ 60". | 2010 ADAS 308.2 & 308.3 | | Relocate the hand sanitizer.<br>Unit Cost: \$50<br>Quantity: 1 | \$50 |

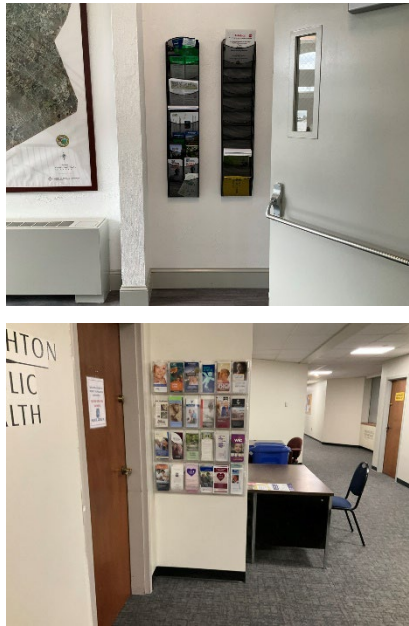
| 19. | <b>Bulletin Boards (Typical)</b><br>Materials displayed on the bulletin boards inside the stairwell (South Side) and near the Visiting Nurse Office are >48". | 2010 ADAS 308.2 & 308.3 | | Relocate the materials to an accessible reach range.<br>Unit Cost: \$50 ea.<br>Quantity: 2 | \$100 |

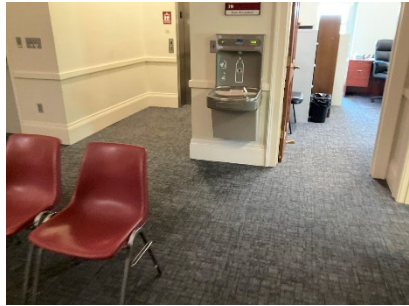
| 20. | <b>Drinking Fountain (Third Floor)</b><br>A drinking fountain for standing users is not provided. | 2010 ADAS 211.2 | | Install a new drinking fountain.<br>Unit Cost: \$1,500 ea.<br>Est. Quantity: 1 | \$1,500 |

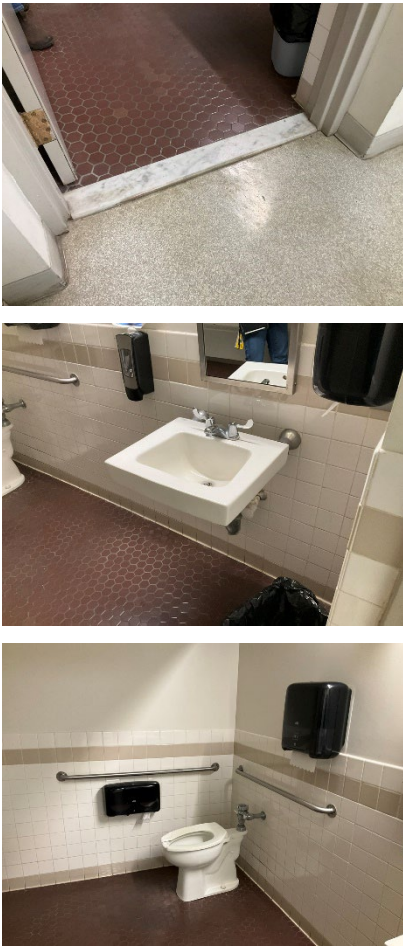
| 22. | <p><b>Men's &amp; Women's Single-User Toilet Rooms (Basement)</b></p> <p>The threshold to the Women's toilet room is &gt; 1/2", @ 3/4".</p> <p>The maneuvering clearance at the door of both toilet rooms is &lt;18" on the latch pull-side, due to the sink.</p> <p>The sink in the Women's toilet room pipes lack insulation.</p> <p>Toilet flush controls the Women's toilet room are not mounted on the open side of the toilet.</p> <p>The paper towel dispenser in both toilet rooms protrudes &gt;4" into the circulation area, @ up to 7".</p> <p>The coat hooks in both toilet rooms are mounted &gt;48", @ 62".</p> <p>The doors of both toilet rooms have hardware that is &gt;48" AFF, @ 60".</p> <p>The side grab bar in the Men's toilet room extends &lt;54" from the rear wall, @ 48".</p> | <p>2010 ADAS 303.2</p> <p>2010 ADAS 404.2.5</p> <p>2010 ADAS 606.5</p> <p>2010 ADAS 604.6</p> <p>2010 ADAS 307.2</p> <p>2010 ADAS 603.4</p> <p>2010 ADAS 404.2.3</p> <p>2010 ADAS 604.5.1</p> | | <p>Replace the threshold.<br/>Unit Cost: \$250<br/>Quantity: 1</p> <p>Install an automatic door opener.<br/>Unit Cost: \$2,500 ea.<br/>Quantity: 1</p> <p>Insulate the pipes underneath the sink.<br/>Unit Cost: \$50 ea.<br/>Quantity: 1</p> <p>Switch the toilet flush controls to the open side or provide automatic flush controls.<br/>Unit Cost: \$250 ea.<br/>Quantity: 2</p> <p>Relocate the paper towel dispenser.<br/>Unit Cost: \$50 ea.<br/>Quantity: 2</p> <p>Install a coat hook mounted no higher than 48" AFF.<br/>Unit Cost: \$50 ea.<br/>Quantity: 2</p> <p>Lower the door locks.<br/>Unit Cost: \$100 ea.<br/>Quantity: 1</p> <p>Relocate the side grab bar.<br/>Unit Cost: \$50 ea.<br/>Quantity: 1</p> | \$3,650 |

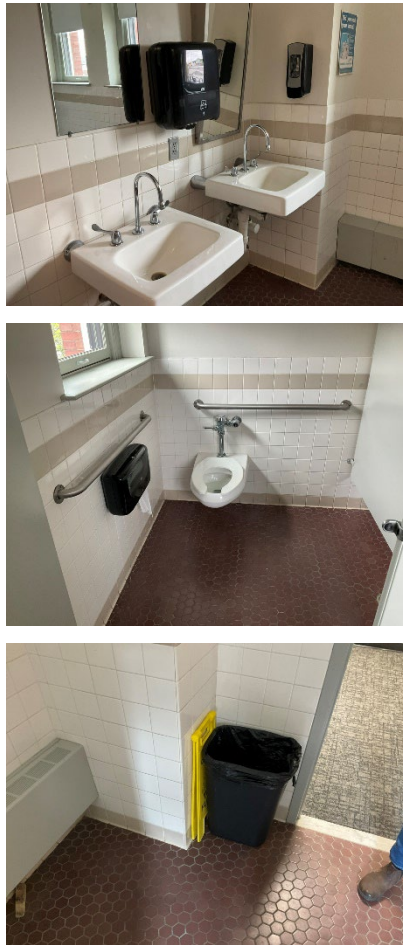
| <p>23.</p> | <p><b>Men's &amp; Women's Multi-User Toilet Rooms (Second Floor)</b></p> <p>The door lacks tactile/Braille signage mounted 60" max. on the latch side (Women's).</p> <p>The threshold is &gt; 1/2", @ 3/4" and is not beveled (Men's).</p> <p>The bottom of the reflective surface of the mirror is &gt;40" AFF, @ 42" (Men's/Women's).</p> <p>The soap dispenser and the paper towel dispenser are &gt;58" AFF, @ up to 50" (Women's).</p> <p>The toilet centerline is not 16"-18" from the nearest adjacent side wall, @ up to 21" (M/Women's).</p> <p>Toilet flush controls are not mounted on the open side of the toilet (Women's).</p> <p>The side grab bars are not located 12" from the interior corner of the wall, @13" (Men's/Women's).</p> <p>The rear grab bars are mounted &gt;6" from the interior corner of the wall, @13" (Men's/Women's).</p> <p>The maneuvering clearance at the door is &lt;18" on the latch pull-side, obstructed by the trash can (Men's).</p> <p>The accessible toilet stall is &lt;60" wide, @ 58" (Men's).</p> <p>The paper towel dispenser in the Men's toilet room protrudes &gt;4" into the circulation area, @ up to 7".</p> | <p>2010 ADAS 216.2</p> <p>2010 ADAS 303.2</p> <p>2010 ADAS 603.3</p> <p>2010 ADAS 307.2</p> <p>2010 ADAS 604.2</p> <p>2010 ADAS 604.6</p> <p>2010 ADAS 604.5.1</p> <p>2010 ADAS 604.5.2</p> <p>2010 ADAS 404.2.5</p> <p>2010 ADAS 604.3.1</p> <p>2010 ADAS 307.2</p> | | <p>Install tactile/ Braille signage on the latch side of the door at 60" AFF maximum.<br/>Unit Cost: \$100 per sign<br/>Quantity: 1</p> <p>Replace the threshold.<br/>Unit Cost: \$250<br/>Quantity: 1</p> <p>Lower the mirror.<br/>Unit cost: \$50 ea.<br/>Quantity: 2</p> <p>Lower the soap dispenser and the paper towel dispenser.<br/>Unit Cost: \$250 ea.<br/>Quantity: 2</p> <p>Reposition the flush valve or install an automatic flush control.<br/>Unit cost: \$1,500<br/>Est. Quantity: 1</p> <p>Relocate the grab bars.<br/>Unit cost: \$50 ea.<br/>Quantity: 4</p> <p>Relocate the trash can.<br/>Unit cost: \$50 ea.<br/>Quantity: 4</p> <p>Reconfigure the toilet stall.<br/>Unit cost: \$5,000 ea.<br/>Quantity: 2</p> <p>Relocate the paper towel dispenser.<br/>Unit Cost: \$50 ea.<br/>Quantity: 1</p> | <p>\$12,900</p> |

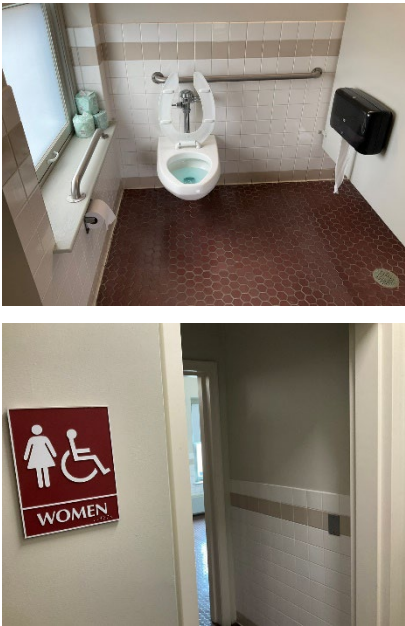
| 24. | <p><b>Men's &amp; Women's Multi-User Toilet Rooms (Third Floor)</b></p> <p>The door to the lacks tactile/Braille signage mounted 60" max. on the latch side (Women's).</p> <p>The bottom of the reflective surface of the mirror is &gt;40" AFF, @ 42" (Men's/Women's).</p> <p>The toilet centerline is not between 16"-18" from the nearest adjacent side wall, @ 20" (Men's/Women's).</p> <p>Toilet flush controls are not mounted on the open side of the toilet (Women's).</p> <p>The toilet paper (TP) dispenser is located &lt;7"- 9" from the front of the toilet, @ 5" (Women's).</p> <p>The accessible toilet stalls are &lt;60" wide, @ up to 58 ½" (Men's/Women's).</p> <p>The rear grab bars are mounted &gt;6" from the interior corner of the wall, @13" (Men's/Women's).</p> <p>The side grab bar extends &lt;54" from the rear wall, @ 44" (Men's).</p> <p>The side grab bar is not mounted on the wall (Women's).</p> <p>The coat hooks are mounted &gt;48", @ 50" (Men's/Women's).</p> | | | <p>Install tactile/ Braille signage on the latch side of the door at 60" AFF maximum.<br/>Unit Cost: \$100 per sign<br/>Quantity: 1</p> <p>Lower the mirror.<br/>Unit cost: \$50 ea.<br/>Quantity: 2</p> <p>Reposition the toilet.<br/>Unit cost: \$1,500 ea.<br/>Est. Quantity: 1</p> <p>Reposition the flush valve or install an automatic flush control.<br/>Unit cost: \$1,500<br/>Est. Quantity: 1</p> <p>Relocate the TP dispenser.<br/>Unit cost: \$50 ea.<br/>Est. Quantity: 1</p> <p>Reconfigure the toilet stall.<br/>Unit cost: \$5,000 ea.<br/>Quantity: 2</p> <p>Add a partition above the window sill and relocate the grab bar.<br/>Unit cost: \$250 ea.<br/>Quantity: 2</p> <p>Relocate the grab bars.<br/>Unit cost: \$50 ea.<br/>Quantity: 2</p> <p>Install a coat hook mounted no higher than 48" AFF.<br/>Unit Cost: \$50 ea.<br/>Quantity: 2</p> | \$13,950 |

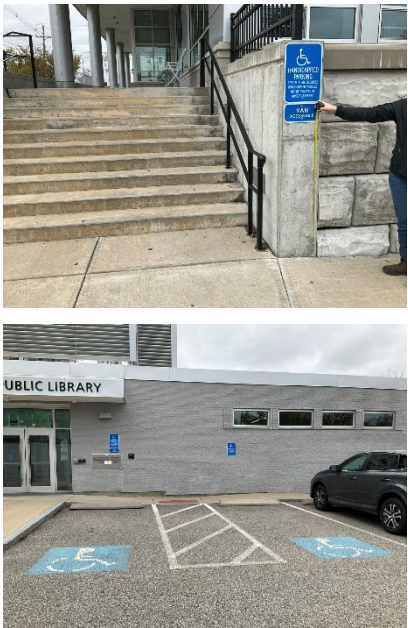
| # | Barrier Statement | Code References | Photo | Proposed Mitigation | Cost |
|---|---|---|---|---|---|
| 1. | <p><b>Parking</b></p> <p>The van parking space signage on the parking lot off Park Street is &lt;60" AFF measured to the bottom of the sign, @ 55".</p> <p>The van parking space closest to the rear entrance (off Walnut Street) is &lt;96" wide, @ 60", measured centerline to centerline.</p> | <p>2010 ADAS 502.6</p> <p>2010 ADAS 502.2</p> | | <p>Install a van accessible sign with the International Symbol of Accessibility at 60" AFF minimum, measured to the bottom of the sign.</p> <p>Unit Cost: \$100 ea.</p> <p>Quantity: 1</p> <p>Restripe a portion of the parking to add the required number of van spaces, as well as their associated signs and access aisles.</p> <p>Unit Cost: \$150 ea.</p> <p>Quantity: 3 (2 spaces, 1 aisle)</p> | \$550 |

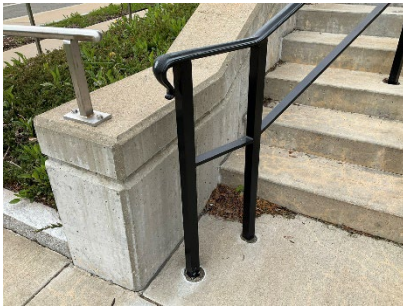
| 3. | <p><b>Exterior Stair</b></p> <p>The handrail gripping surface of the stairs between the parking lot off Park Street and the main entrance does not have a perimeter dimension between 4"-6 ¼".</p> | 2010 ADAS<br>505.7.1 | | Install compliant handrails on both sides of the stairs.<br>Unit Cost: \$50/LF<br>Est. Quantity: 28 | \$1,400 |

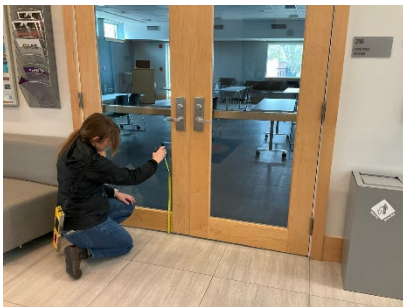
| 4. | <p><b>Door Kickplate (Typical)</b></p> <p>Certain doors provide a smooth surface &lt;10" AFF on the push side, @ up to 8 ¾".</p> <p><i>Observed at entrance vestibules, 316 Meeting Room, 217 Historical Room, 224 Literacy Coordinator, Quiet/Tutor Rooms, 223 Program Administrator, 232 Library Director, and 231 Conference Room.</i></p> | 2010 ADAS<br>404.2.10 | | Replace the door with a door with a bottom rail at least 10" min. AFF.<br>Unit Cost: \$1,000 ea.<br>Quantity: 12 | \$1,200 |

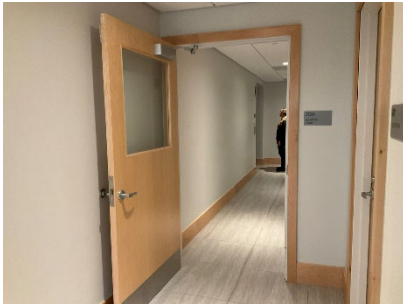
| 5. | <p><b>Door Vision Lights (Typical)</b></p> <p>A few doors have a glazing panel &gt;43" AFF, @ up to 48".</p> <p><i>Observed at 205 Tech Services, 208 Custodian Office, and elevator lobby.</i></p> | 2010 ADAS<br>404.2.11 | | Replace the door with a door with a compliant glazing panel.<br>Unit Cost: \$1,000 ea.<br>Quantity: 3 | \$3,000 |

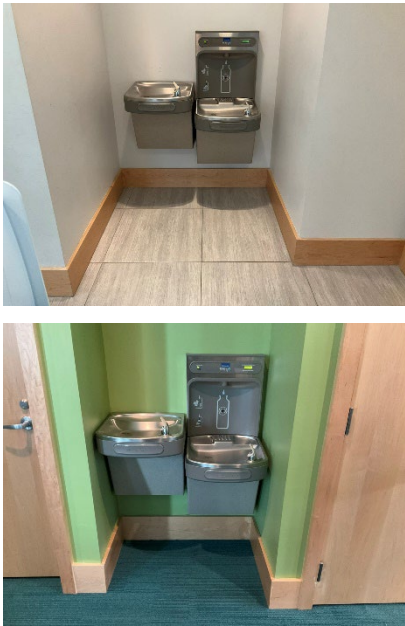
| 6. | <p><b>Drinking Fountains</b></p> <p>The knee space is &lt;27" AFF under the fountain, @ 26 1/4".</p> <p><i>Observed at drinking fountains on both the first and second floors.</i></p> <p>The knee space is not centered under the drinking fountain on the second floor, @ 10".</p> | ADA 602.2 | | <p>Raise the drinking fountain.<br/>Unit Cost: \$750 ea.<br/>Quantity: 1</p> <p>Relocate the drinking fountain.<br/>Unit Cost: \$1,500 ea.<br/>Quantity: 1</p> | \$2,250 |

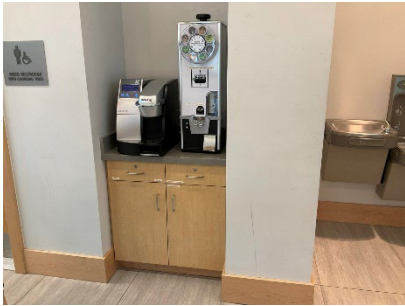
| 7. | <p><b>K-cup Dispenser</b></p> <p>The knob at the top of the K-cup dispenser on the second-floor lobby is mounted &gt;48" AFF, @ 66", and requires tight grasping, pinching, and/or twisting of the wrist to operate.</p> | <p>2010 ADAS 308.2<br/>&amp; 308.3</p> <p>2010 ADAS 309.4</p> | | <p>Lower the K-cup dispenser.<br/>Unit Cost: \$50 ea.<br/>Quantity: 1</p> | \$50 |

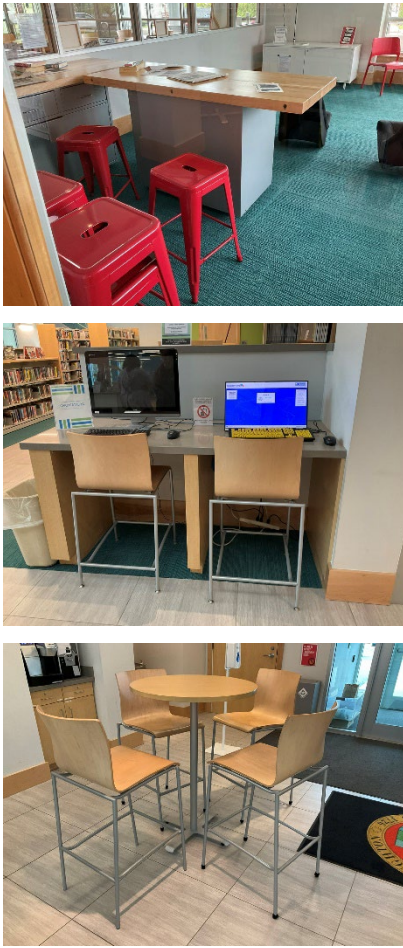
| 8. | <p><b>Work Surfaces (Typical)</b></p> <p>The table inside 115 Young Adult and the computer desk at the Teen Space on the first floor and the tall table on the second-floor lobby are &gt;34" AFF, @ 36", 35 ¾", and 42", respectively.</p> <p>The computer desks on the first floor lacks the required knee and toe clearance for a forward approach.</p> | <p>2010 ADAS 902.3</p> <p>2010 ADAS 306.2 &amp; 306.3</p> | <p>The top photograph shows a red table with four red stools in a room with green carpeting. The middle photograph shows a computer desk with two orange chairs, a monitor, and a laptop. The bottom photograph shows a round wooden table with four orange chairs on a tiled floor.</p> | <p>Provide at least one table and computer desk, and no less than 5% of the total number of tables and desks, that provides compliant knee and toe clearance.</p> <p>Unit Cost: \$250 ea.<br/>Est. Quantity: 3</p> | \$750 |

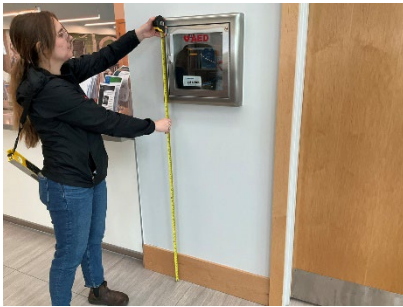
| 9. | <b>AED Cabinet</b><br>The pull of the AED box on the first-floor lobby is mounted >48" AFF, @ 58". | 2010 ADAS 308.2 & 308.3 | | Relocate the AED box.<br>Unit Cost: \$50 ea.<br>Quantity: 1 | \$50 |

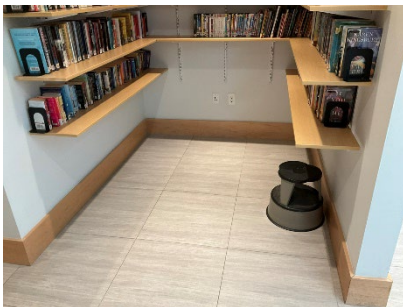
| 10. | <b>Protruding Objects</b><br>The shelving near the elevator lobby on the second floor protrude >4" into the circulation space, @ 20". | 2010 ADAS 307.2 | | Install wing walls on the ends of the lower shelving.<br><br>Unit Cost: \$250 ea.<br>Quantity: 2 | \$500 |

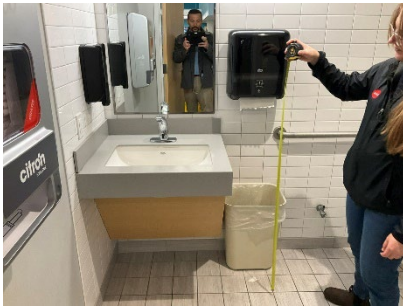
| 12. | <p><b>Single-user Toilet Room (First Floor)</b></p> <p>The threshold to the toilet room is <math>&gt;1\frac{1}{2}</math>", @ <math>5/8</math>".</p> <p>The paper towel dispenser and the feminine care dispenser protrude <math>&gt;4</math>" into the circulation space, @ <math>8</math>".</p> | <p>2010 ADAS 404.2.5</p> <p>2010 ADAS 307.2</p> | | <p>Replace the threshold.<br/>Unit Cost: \$250<br/>Quantity: 1</p> <p>Relocate the paper towel dispenser and the feminine care dispenser.<br/>Unit Cost: \$50 ea.<br/>Quantity: 2</p> | \$350 |

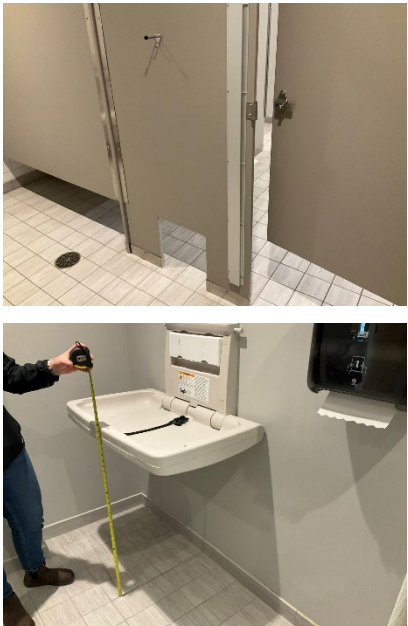
| 14. | <p><b>Men's and Women's Toilet Rooms (Second Floor)</b></p> <p>The coat hook is mounted &gt;48" AFF, @ up to 52".</p> <p>The paper towel dispenser protrudes &gt;4" into the circulation space, @ 8".</p> <p>The changing station is &gt;34" AFF, @ 36" AFF.</p> | <p>2010 ADAS 308.2 &amp; 308.3</p> <p>2010 ADAS 307.2</p> <p>2010 ADAS 902.3</p> | | <p>Install a coat hook mounted no higher than 48" AFF.<br/>Unit Cost: \$50 ea.<br/>Quantity: 2</p> <p>Relocate the paper towel dispenser.<br/>Unit Cost: \$50 ea.<br/>Quantity: 2</p> <p>Relocate the changing station.<br/>Unit Cost: \$250 ea.<br/>Quantity: 2</p> | \$700 |

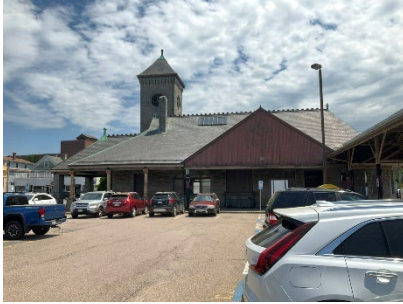
| TRAIN DEPOT | | | | | |
|---|---|---|---|---|---|
| 1. | <b>Parking</b><br>There is an insufficient number of accessible parking spaces. | 2010 ADAS 208.2 | | Restripe a portion of the parking to add the required number of accessible parking spaces, including van spaces, as well as their associated signs and access aisles.<br>Unit Cost: \$150 ea.<br>Est. Quantity: 1 | \$150 |

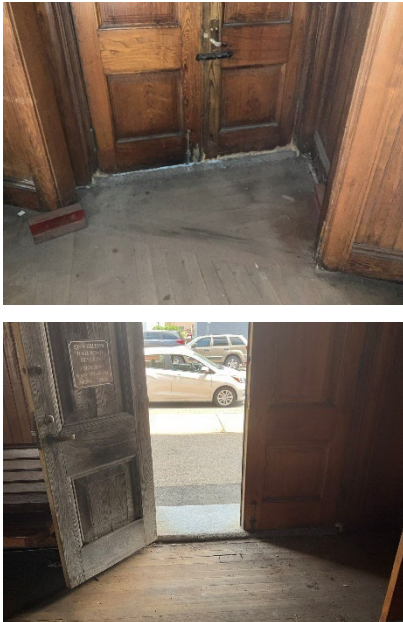
| TRAIN DEPOT | | | | | |
|---|---|---|---|---|---|
| 2. | <b>Building</b><br>There is no accessible route to and within the building. The building interior lacks multiple accessible spaces and elements, including toilet rooms. | 2010 ADAS 206 | | When designing the building renovation, provide an accessible route to and within the building and ensure that the building is fully accessible. Further design study is required.<br><br>Unit Cost: \$100,000 ea.<br>Quantity: 1 | \$100,000 |

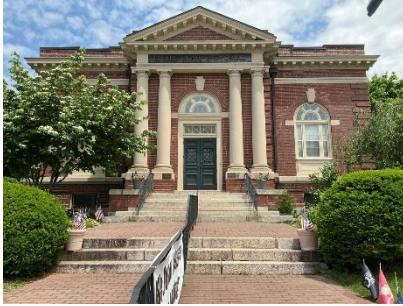
| HISTORICAL SOCIETY | | | | | |
|---|---|---|---|---|---|
| 1. | <b>Outdoor Stairs</b><br>The bottom section and some sections at the top of the staircase lack continuous handrails on both sides.<br><br>At the top section of stairs, the bottom handrails extend <12". | 2010 ADAS 505 | | Install compliant handrail extensions on both sides of the stairs.<br>Unit Cost: \$80/LF<br>Est. Quantity: 100 LF | \$8,000 |

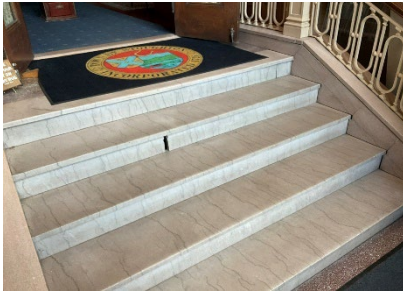
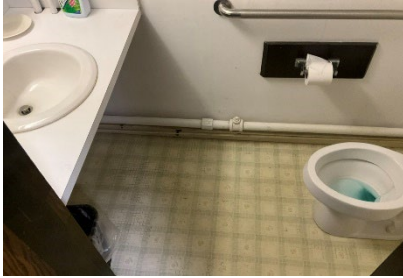
| HISTORICAL SOCIETY | | | | | |
|---|---|---|---|---|---|
| 2. | <b>Building</b><br>There is no accessible route into and throughout the building due to stairs. The building interior lacks multiple accessible spaces and elements, including toilet rooms. | 2010 ADAS 206<br><br>2010 ADAS 604.3.1 | <br> | When designing the building renovation, provide an accessible route to and within the building and ensure that the building is fully accessible. Further design study is required.<br>Unit Cost: \$100,000 ea.<br>Quantity: 1 | \$100,000 |

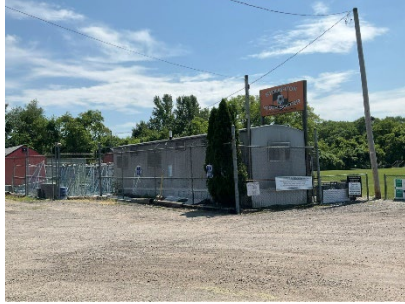
| ANIMAL CONTROL | | | | | |
|---|---|---|---|---|---|
| 1. | <b>Parking</b><br>There is an insufficient number of accessible parking spaces. In addition, the surface of the parking lot is not stable, firm, or slip resistant due to gravel surface. | 2010 ADAS 208 | | Restripe a portion of the parking lot to add the required number of accessible parking spaces, including van spaces, as well as their associated signs and access aisles.<br>Unit Cost: \$10,000 ea.<br>Est. Quantity: 1 | \$10,000 |

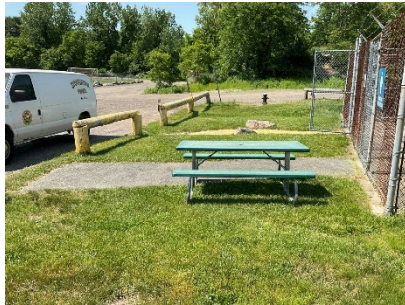
| ANIMAL CONTROL | | | | | |
|---|---|---|---|---|---|
| 2. | <b>Picnic Table</b><br>The picnic table is not located along an accessible route due to the grass surface.<br><br>The picnic table lacks the required knee/toe clearance for a forward approach. | 2010 ADAS 206<br>2010 ADAS 305 | | Provide an accessible picnic table along the accessible route.<br>Unit Cost: \$250 ea.<br>Est. Quantity: 1 | \$250 |

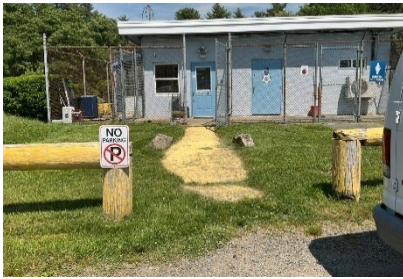
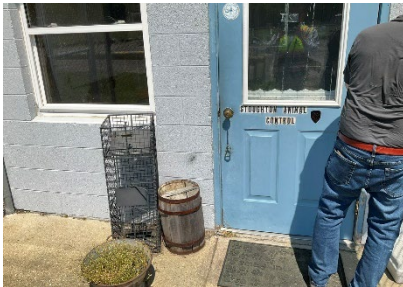
| 4. | <p><b>Entrance</b></p> <p>The door lacks a level landing due to areas of deterioration.</p> <p>The door maneuvering clearance on the pull side is obstructed by the barrel.</p> <p>The door hardware requires tight grasping, pinching and twisting of the wrist due to knob type.</p> | <p>2010 ADAS 302</p> <p>2010 ADAS 404</p> | | <p>Regrade the door landing<br/>Unit Cost: \$250 ea.<br/>Quantity: 1</p> <p>Replace the door hardware with a lever type.<br/>Unit Cost: \$300 ea.<br/>Quantity: 1</p> <p>Relocate the barrel.<br/>Unit Cost: \$50 ea.<br/>Quantity: 1</p> | \$600 |

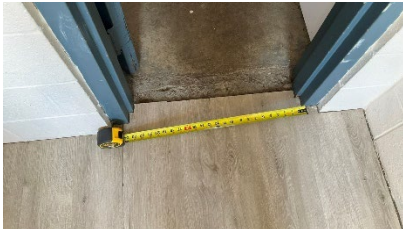
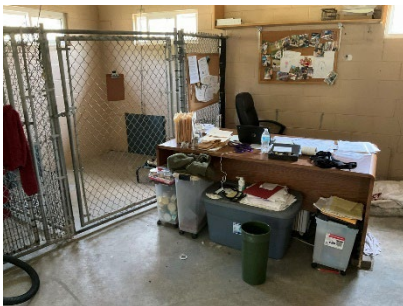
| 5. | <p><b>Interior Conditions</b></p> <p>The building interior lacks multiple accessible spaces and elements, including narrow doors @ up to 22" wide, a toilet room that do not meet dimensional requirements, and a second means of egress leading to an enclosed dog cage.</p> | <p>2010 ADAS 404</p> <p>2010 ADAS 604</p> | | <p>When designing the building renovation, provide an accessible route to and within the building and ensure that the building is fully accessible. Further design study is required.<br/>Unit Cost: \$10,000 ea.<br/>Quantity: 1</p> | \$10,000 |

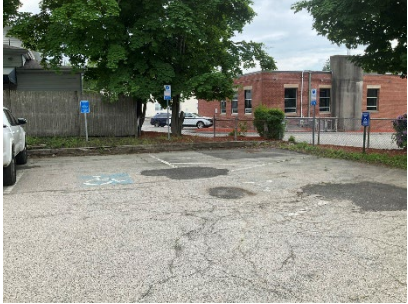
| # | Barrier Statement | Code References | Photo | Proposed Mitigation | Cost |
|---|---|---|---|---|---|
| 1. | <p><b>Parking</b></p> <p>The width of the access aisle measured &lt;60" wide from centerline to centerline.</p> <p>The designated accessible parking spaces and their associated access aisles have slopes &gt;2%.</p> <p>The designated accessible parking space signs are mounted &gt;60" @ 44", measured to the bottom of the sign.</p> | <p>2010 ADAS 502.6</p> <p>2010 ADAS 502.4</p> | | <p>Regrade and restripe the existing designated parking spaces and their associated access aisles.</p> <p>Unit Cost: \$1,500 ea.</p> <p>Quantity: 3 (2 spaces, 1 aisle)</p> <p>Install a sign with the International Symbol of Accessibility at 60" AFF minimum, measured to the bottom of the sign. Include a van accessible sign where applicable.</p> <p>Unit Cost: \$100 ea.</p> <p>Quantity: 2</p> | \$4,700 |

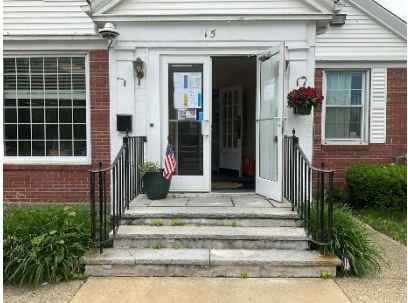
| # | Barrier Statement | Code References | Photo | Proposed Mitigation | Cost |
|---|---|---|---|---|---|
| 2. | <p><b>Front Entrance</b></p> <p>The facility lacks directional signage identifying the location of the accessible entrance located at the rear of the building.</p> | <p>2010 ADAS 216.6</p> | | <p>Install tactile/braille signage with the International Symbol of Accessibility (ISA) where required.</p> <p>Unit Cost: \$100 ea.</p> <p>Est. Quantity: 1</p> | \$100 |

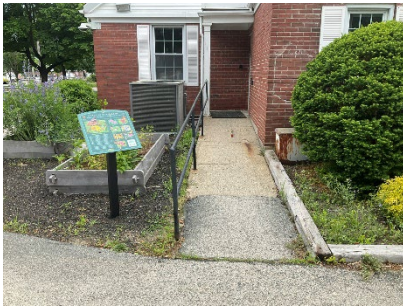
| 3. | <p><b>Exterior Ramp</b></p> <p>The ramp leading to the accessible entrance had slopes &gt;8.3%, @ up to 9.2%.</p> <p>The ramp lacks continuous handrails on both sides. In addition, at the one handrail that is provided, it extends &lt;12".</p> <p>There are changes in level at the bottom of the ramp &gt; 1/2" and are not beveled with a maximum 1:2 slope.</p> | <p>2010 ADAS 405.2</p> <p>2010 ADAS 303</p> <p>2010 ADAS 505</p> | | <p>Rebuild the ramp, including installing compliant handrails on both sides of the ramp.</p> <p>Unit Cost: \$15,000 ea.</p> <p>Quantity: 1</p> | \$15,000 |

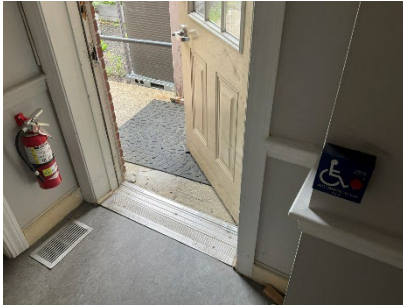
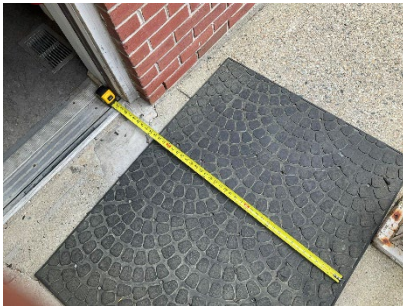
| 4. | <p><b>Rear Entrance</b></p> <p>The pull side door maneuvering on the latch side perpendicular to the door measured &lt;60", @ 40" to the opposing post. Note: an automatic door opener is provided on both sides of the door, however at the time of the audit, both door openers were malfunctioning.</p> | <p>2010 ADAS 404</p> | | <p>Fix automatic door opener.</p> <p>Unit Cost: \$1,000 ea.</p> <p>Quantity: 1</p> | \$1,000 |

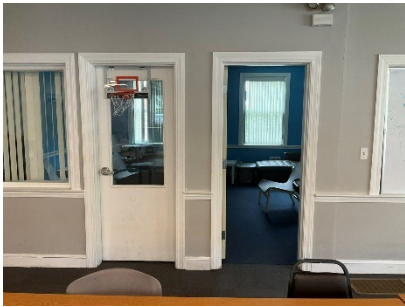
| 5. | <b>Signage</b><br>All the rooms open to the public lack permanent signage mounted on the latch side of the door. | 2010 ADAS 703 | | Install tactile/Braille signage on the latch side of the door.<br>Coordinate with location and height requirements.<br>Unit Cost: \$100 ea.<br>Est. Quantity: 6 | \$600 |

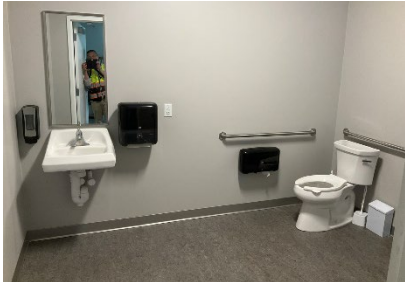
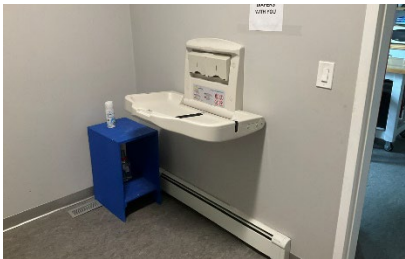
| 6. | <b>Single-User Toilet Room</b><br>The signage is not mounted on the latch side of the door.<br>The pull side door maneuvering clearance for a forward approach scaled <12", @ 5" due to fire shelving obstruction.<br>The toilet centerline is not 16"-18" from the side wall, @ 18 1/2".<br>The top of the baby changing work surface measured >34" AFF, @ 39".<br>In addition, the handle is not within reach range. | 2010 ADAS 703<br>2010 ADAS 404<br>2010 ADAS 604 | <br><br> | Relocate the signage.<br>Unit Cost: \$100 ea.<br>Quantity: 1<br><br>Reposition the toilet<br>Unit Cost: \$1,500 ea.<br>Quantity: 1<br><br>Provide a compliant baby changing table.<br>Unit Cost: \$100 ea.<br>Quantity: 1 | \$1,700 |

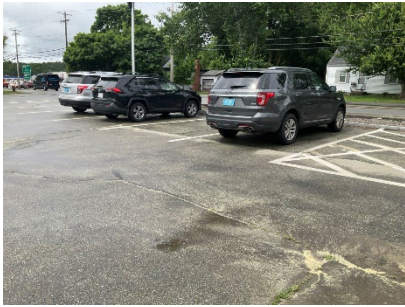
| # | Barrier Statement | Code References | Photo | Proposed Mitigation | Cost |
|---|---|---|---|---|---|
| 1. | <b>Parking</b><br>There is an insufficient number of accessible parking spaces provided. | 2010 ADAS 208.2 | | Restripe a portion of the parking to add the required number of accessible parking spaces, including van spaces, as well as their associated signs and access aisles.<br>Unit Cost: \$1,500 ea.<br>Est. Quantity: 1 | \$1,500 |

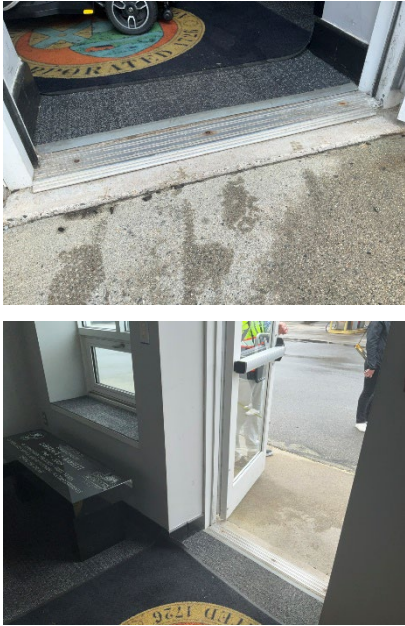
| # | Barrier Statement | Code References | Photo | Proposed Mitigation | Cost |
|---|---|---|---|---|---|
| 2. | <b>Entrance</b><br>The exterior threshold measured > 1/2" AFF, @ 5/8".<br>The door is located in a recess >8" deep, @ 11" on the push side and therefore does not provide the required door maneuvering clearance.<br>The hand sanitizer dispenser is mounted >48" AFF, @ 53". | 2010 ADAS 404 | | Replace the threshold.<br>Unit Cost: \$250 ea.<br>Quantity: 1<br>Install an automatic door opener.<br>Unit Cost: \$2,500 ea.<br>Quantity: 1<br>Lower the hand sanitizer.<br>Unit Cost: \$50<br>Quantity: 1 | \$2,800 |

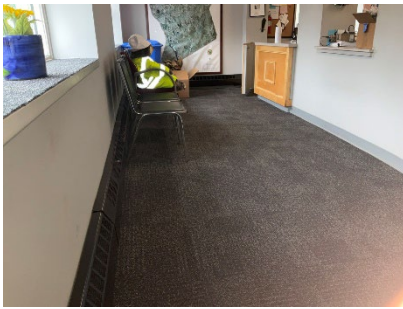
| 4. | <b>Counters</b><br><p>The height of the counters dedicated to different departments measured &gt;36", @ 42".</p> <p>The water/sewer counter lacks a level clear floor space due to the location of the ramp.</p> | 2010 ADAS 305<br>2010 ADAS 606 | | <p>Lower the counters.<br/> Unit Cost: \$2,500 ea.<br/> Quantity: 2</p> <p>Remove the counter over the ramp.<br/> Unit Cost: \$50 ea.<br/> Quantity: 1</p> | \$5,050 |

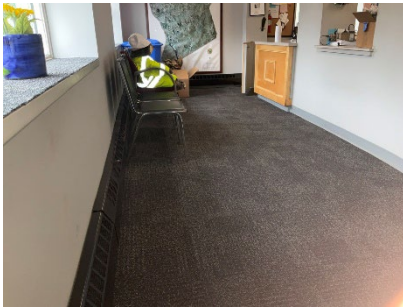
| 5. | <b>Ramp</b><br><p>The walkway through the front office has slopes &gt;5%, @ 8.2% and is not treated as a ramp.</p> <p>The ramp lacks a level landing &lt;60" long, @ 48".</p> | 2010 ADAS 405 | | <p>Rebuild the ramp, including installing compliant handrails on both sides of the ramp. Further design study is required.<br/> Unit Cost: \$5,000 ea.<br/> Quantity: 1</p> | \$5,000 |

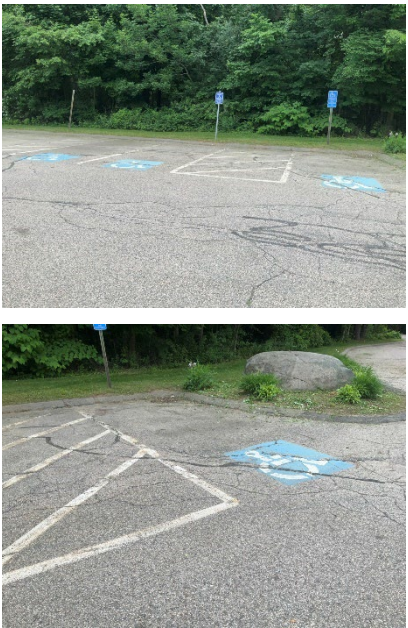
| # | Barrier Statement | Code References | Photo | Proposed Mitigation | Cost |
|---|---|---|---|---|---|
| 1. | <p><b>Parking at Edge of Parking Lot</b></p> <p>Some of the designated accessible parking spaces had slopes &gt;2%, @ up to 7.2%.</p> <p>Some of the accessible spaces ground surface is not stable, firm or slip resistant due to material deterioration.</p> <p>One of the three accessible spaces lack signage indicating they are accessible. At others, the signage is mounted &lt;60", @ 38", measured to the bottom of the sign.</p> | <p>ADAS 502.4</p> <p>ADAS 502.6</p> | | <p>Regrade and restripe the existing designated parking spaces and their associated access aisles.<br/>Unit Cost: \$1,500 ea.<br/>Quantity: 4 (3 spaces, 1 aisle)</p> <p>Install a sign with the International Symbol of Accessibility at 60" AFF minimum, measured to the bottom of the sign. Include a van accessible sign where applicable.<br/>Unit Cost: \$100 ea.<br/>Quantity: 3</p> | \$6,300 |

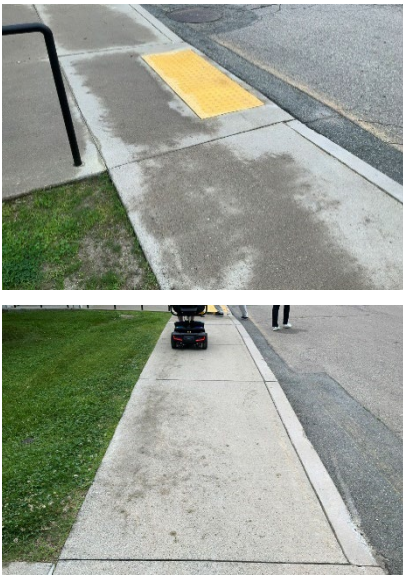
| 3. | <p><b>Walkway Between Parking and Entrance</b></p> <p>The ramp lacks a level landing <math>\leq 2\%</math>, @ up to 7.6%.</p> <p>The sidewalk has cross slopes &gt;2%, @ up to 4.9%.</p> | <p>2010 ADAS 405.7</p> <p>2010 ADAS 403.3</p> | | <p>Rebuild the curb ramp.<br/>Unit cost: \$1,250 ea.<br/>Quantity: 1</p> <p>Regrade the walkway.<br/>Unit Cost: \$25/SF<br/>Est. Quantity: 150 SF</p> | \$5,000 |

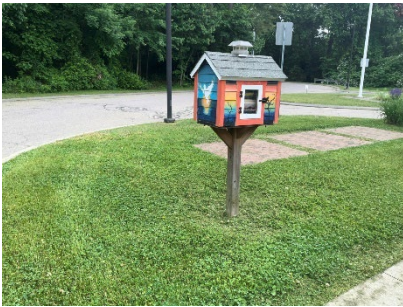
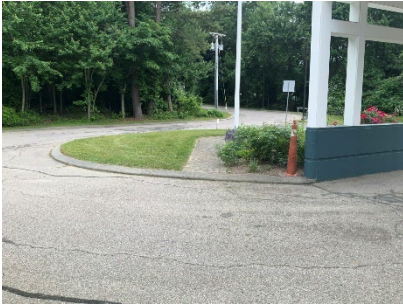
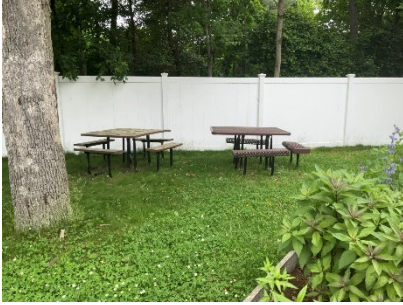
| 4. | <p><b>Site Amenities</b></p> <p>Some site amenities (i.e. book box, flagpole, picnic tables, gardens) are not located along an accessible route due to the grass surface.</p> <p>The topmost controls at the donation bin located on the parking lot measured &gt;48" AFF, @ 60".</p> | <p>2010 ADAS 206.1</p> <p>2010 ADAS 308.2.1</p> | | <p>Provide an accessible route to at least one of each type of site amenity.</p> <p>Unit Cost: \$25/SF<br/>Est. Quantity: 200 SF</p> <p>Provide a bin with controls within reach range.</p> <p>Unit Cost: \$500 ea.<br/>Quantity: 1</p> | \$5,500 |

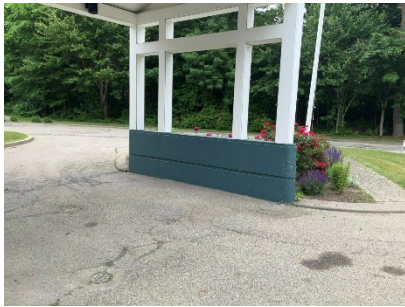
| 5. | <b>Drop-off within Carport</b><br>The access aisle serving the vehicle pull-up space is not marked. | 2010 ADAS 503.3.3 | | Provide markings at the access aisle to discourage parking.<br>Unit Cost: \$300 ea.<br>Quantity: 1 | \$300 |

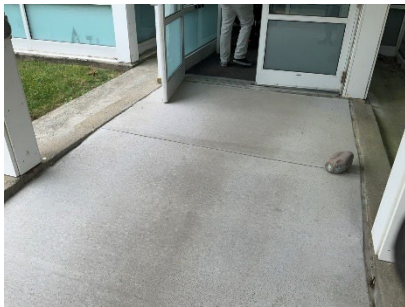
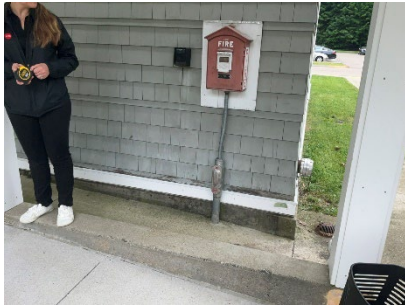
| 6. | <b>Main Entrance</b><br>The walkway leading to the main entrance has running slopes >5%, @ 6.7%, and is not treated as a ramp.<br><br>The push button of the automatic door opener is not located on an accessible route due to its placement along the ramp.<br><br>The pull station is not located on an accessible route due to its placement along the ramp and is mounted >44" AFF over a 20"-25" obstruction. | 2010 ADAS 405.3<br>2010 ADAS 405<br>2010 ADAS 206.1 | <br> | Rebuild the curb ramp.<br>Unit cost: \$1,250 ea.<br>Quantity: 1<br><br>Relocate both the push button and the pull station to an accessible location.<br>Unit Cost: \$250 ea.<br>Quantity: 2 | \$1,750 |

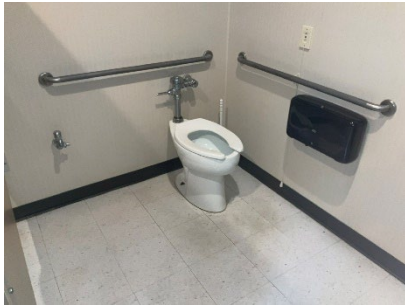
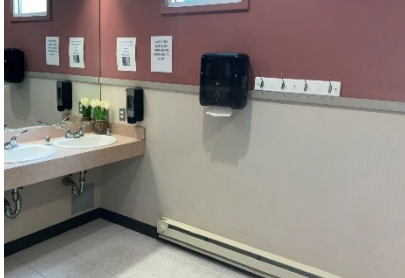
| 8. | <b>Women's Toilet Room</b><br>The pipes underneath the lavatory are not insulated.<br>The side grab bar extends <54" from the rear wall, @48".<br>The toilet centerline is not 16"-18" from the nearest adjacent side wall, @ 18 1/2".<br>The coat hook is >48" AFF, @ 64".<br>The paper towel dispenser protrudes >4" into the circulation space. | 2010 ADAS 606.5<br>2010 ADAS 604.5.1<br>2010 ADAS 604.2<br>2010 ADAS 604.8.3<br>2010 ADAS 307.2 | | Insulate the pipes.<br>Unit Cost: \$50 ea.<br>Quantity: 1<br>Relocate the grab bar.<br>Unit Cost: \$50 ea.<br>Quantity: 1<br>Reposition the toilet.<br>Unit Cost: \$500 ea.<br>Quantity: 1<br>Provide a coat hook mounted no higher than 48" AFF.<br>Unit Cost: \$50 ea.<br>Quantity: 1<br>Relocate paper towel dispenser.<br>Unit Cost: \$50 ea.<br>Quantity: 1 | \$700 |

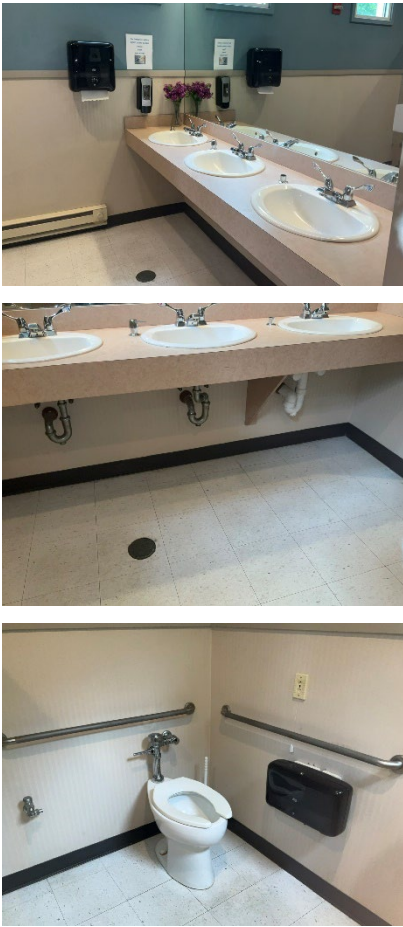
| 9. | <p><b>Men's Toilet Room</b></p> <p>The pipes underneath the lavatory are not insulated.</p> <p>The lavatory is mounted &gt;34" AFF, @34 ¾".</p> <p>The paper towel dispenser is mounted &gt;48" AFF, @ 54", to the highest operable part.</p> <p>The side grab bar extends &lt;54" from the rear wall, @49".</p> <p>The toilet centerline is not 16"-18" from the nearest adjacent side wall, @ 18 ¼".</p> <p>The coat hook is &gt;48" AFF, @ 64".</p> <p>The urinal does not provide the required clear floor space in front of it, @ 29".</p> | <p>2010 ADAS 606.5</p> <p>2010 ADAS 606.3</p> <p>2010 ADAS 308.3</p> <p>2010 ADAS 604.5.1</p> <p>2010 ADAS 604.2</p> <p>2010 ADAS 604.8.3</p> <p>2010 ADAS 605.3</p> | | <p>Insulate the pipes.<br/>Unit Cost: \$50 ea.<br/>Quantity: 1</p> <p>Lower the lavatory.<br/>Unit Cost: \$750 ea.<br/>Quantity: 1</p> <p>Relocate paper towel dispenser.<br/>Unit Cost: \$50 ea.<br/>Quantity: 1</p> <p>Relocate the grab bar.<br/>Unit Cost: \$50 ea.<br/>Quantity: 1</p> <p>Reposition the toilet.<br/>Unit Cost: \$500 ea.<br/>Quantity: 1</p> <p>Provide a coat hook mounted no higher than 48" AFF.<br/>Unit Cost: \$50 ea.<br/>Quantity: 1</p> <p>Relocate the urinal partitions.<br/>Unit Cost: \$250 ea.<br/>Quantity: 1</p> | \$1,800 |

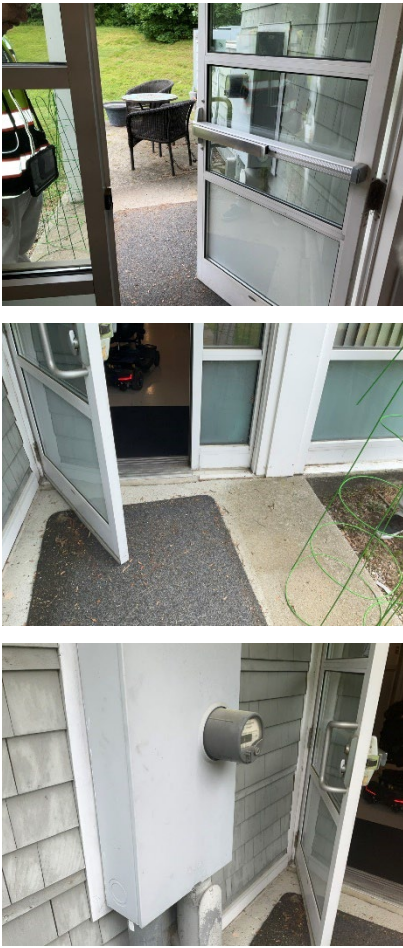
| 10. | <p><b>Rear Patio</b></p> <p>The entry door gets stuck on the rug and lacks the required minimum 18" of maneuvering clearance on the latch push side for a forward approach, due to electric meter @ 45".</p> <p>Electric meter protrudes &gt;4" into the circulation space, @ 12".</p> <p>The table lacks the required knee and toe clearance for a forward approach due to its pedestal base.</p> | <p>2010 ADAS 404.2.3</p> <p>2010 ADAS 307.2</p> <p>2010 ADAS 902.4.1</p> | | <p>Install an automatic door opener.<br/>Unit Cost: \$2,500 ea.<br/>Quantity: 1</p> <p>Install a cane detectable object below the electric meter.<br/>Unit Cost: \$250 ea.<br/>Quantity: 1</p> <p>Provide at least one table, and no less than 5% of the total number of tables, that provides compliant knee and toe clearance.<br/>Unit Cost: \$250 ea.<br/>Est. Quantity: 1</p> | \$3,000 |

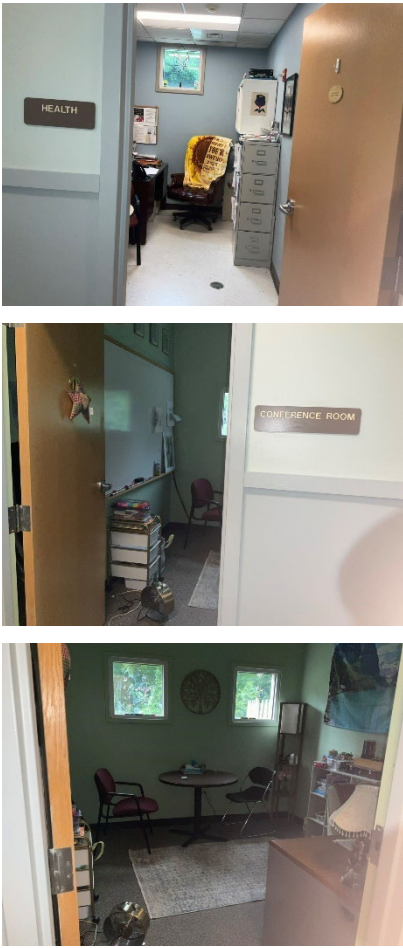
| 11. | <p><b>Health Office and Conference Room</b></p> <p>The maneuvering clearance at the doors are &lt;18" on the latch pull-side, obstructed by furniture.</p> <p>The tables lack the required knee and toe clearance for a forward approach due to their pedestal base.</p> | <p>2010 ADAS<br/>404.2.4</p> <p>2010 ADAS<br/>902.4.1</p> | | <p>Relocate the furniture.<br/>Unit Cost: \$50 ea.<br/>Quantity: 2</p> <p>Provide at least one table, and no less than 5% of the total number of tables, that provides compliant knee and toe clearance.<br/>Unit Cost: \$250 ea.<br/>Est. Quantity: 2</p> | \$600 |
