## STOUGHTON BUILDING AUDITS

*KMA audited the following municipal buildings:*

## TOWN HALL

*AUDITED ON: MAY 1, 2024*

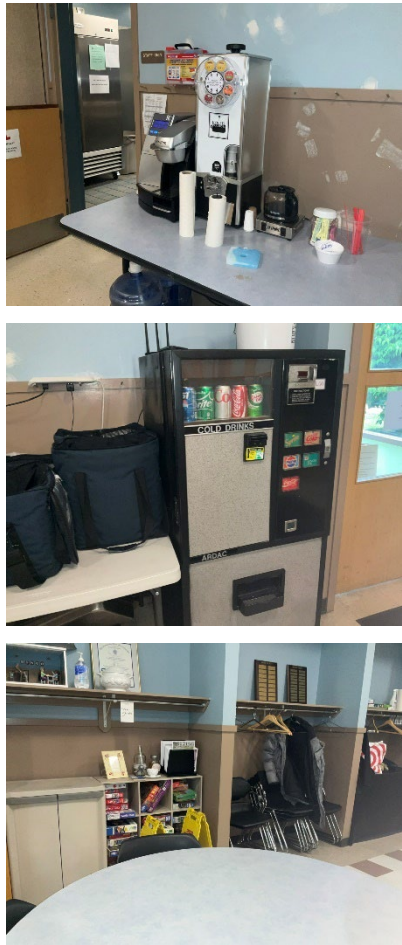
| 12. | <p><b>Community Room</b></p> <p>The door maneuvering clearance is &lt;12" on the latch, push side for a front approach, @ 9".</p> <p>The knob at the top of the coffee cup dispenser is mounted &gt;48" AFF, @ 54",</p> <p>The coin slot of the vending machine is mounted &gt;48" AFF, @ 54".</p> <p>The coat rack is mounted &gt;48" AFF, @ 61".</p> <p>The table lacks the required knee and toe clearance for a forward approach due to the lack of 30" clearance between legs.</p> | <p>2010 ADAS 404.2.4.1</p> <p>2010 ADAS 308.2.1</p> <p>2010 ADAS 902.4.1</p> | | <p>Install an automatic door opener.<br/>Unit Cost: \$2,500 ea.<br/>Quantity: 1</p> <p>Lower the coffee cup dispenser and the coat rack.<br/>Unit Cost: \$50 ea.<br/>Quantity: 2</p> <p>Replace the vending machine.<br/>Unit Cost: \$250 ea.<br/>Quantity: 1</p> <p>Provide at least one table, and no less than 5% of the total number of tables, that provides compliant knee and toe clearance.<br/>Unit Cost: \$250 ea.<br/>Est. Quantity: 1</p> | \$3,100 |

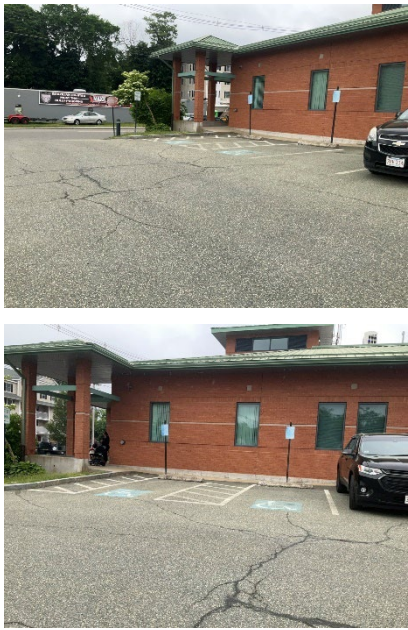
| POLICE STATION | | | | | |
|---|---|---|---|---|---|
| 1. | <p><b>Parking</b></p> <p>The accessible parking spaces have slopes &gt;2%, @ up to 5.2%.</p> <p>The designated van accessible access aisle is &lt;96" wide, @ 60", measured centerline to centerline.</p> <p>The van accessible parking space lacks the required signage.</p> | <p>2010 ADAS 502.4</p> <p>2010 ADAS 502.2</p> <p>2010 ADAS 502.6</p> | | <p>Regrade and restripe the existing designated parking spaces, including one van accessible parking space, and their associated signs and access aisles.</p> <p>Unit Cost: \$1,500 ea.</p> <p>Quantity: 3 (2 spaces + 1 aisle)</p> | \$4,500 |

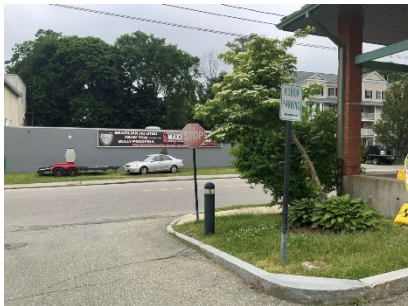
| POLICE STATION | | | | | |
|---|---|---|---|---|---|
| 2. | <p><b>Walkway Between Street and Accessible Entrance</b></p> <p>The walkway between Rose Street and the accessible entrance has running slopes &gt;5%, @ up to 11.8%, due to the steep vehicular ramp to the parking lot.</p> | <p>2010 ADAS 206.1</p> | | <p>Construct a new ramp leading to the accessible entrance. Further design study required.</p> <p>Unit Cost: \$15,000 ea.</p> <p>Quantity: 1</p> | \$15,000 |

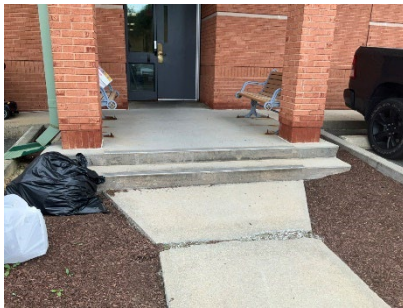
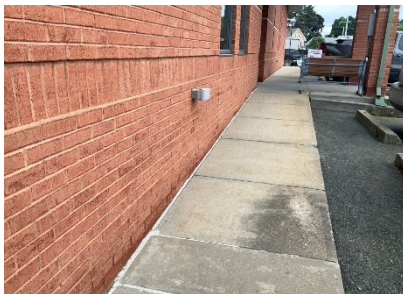
| 4. | <p><b>Walkway Between Parking and Employee Entrance</b></p> <p>The stairs leading to the employee entrance do not have handrails on both sides.</p> <p>The walkway has running slopes &gt;5% and is not treated as a ramp, @ up to 5.7%.</p> <p>The outdoor outlet protrudes &gt;4" into the circulation space, @ 5 1/2".</p> | <p>2010 ADAS 505.2<br/>2010 ADAS 403.3<br/>2010 ADAS 307.2</p> | | <p>Install compliant handrails on both sides of the stairs.<br/>Unit Cost: \$50/LF<br/>Quantity: 8 LF</p> <p>Provide compliant handrails on both sides of the walkway.<br/>Unit Cost: \$50/LF<br/>Quantity: 60 LF</p> <p>Install a cane detectable object below the outlet.<br/>Unit Cost: \$250 ea.<br/>Quantity: 1</p> | \$3,650 |

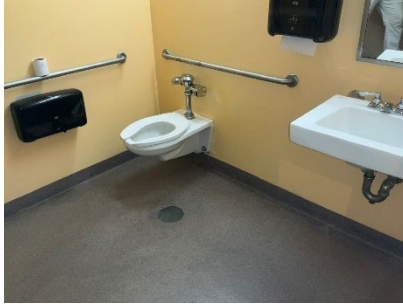
| 7. | <p><b>Single-user Toilet Room at Lobby</b></p> <p>The push side door maneuvering clearance is &lt;12" on the latch side for a front approach, @ 4", due to the sharp container disposal.</p> <p>Sink pipes are not insulated.</p> <p>The bottom of the reflective surface of the mirror is &gt;40" AFF, @ 41".</p> <p>The paper towel dispenser protrudes &gt;4" into the circulation area, @ 8".</p> <p>The coat hook is mounted &gt;48" AFF, @ 65".</p> <p>The side grab bar extends &lt;54" from the rear wall, @ 48".</p> | <p>2010 ADAS 404.2.4.1</p> <p>2010 ADAS 606.5</p> <p>2010 ADAS 603.3</p> <p>2010 ADA 307.2</p> <p>2010 ADAS 604.8.3</p> <p>2010 ADAS 604.5.1</p> | | <p>Relocate the sharp container disposal.<br/>Unit Cost: \$50 ea.<br/>Quantity: 1</p> <p>Insulate the pipes underneath the sink.<br/>Unit Cost: \$50 ea.<br/>Quantity: 1</p> <p>Lower the mirror.<br/>Unit Cost: \$50<br/>Quantity: 1</p> <p>Relocate the dispenser.<br/>Unit Cost: \$50<br/>Quantity: 1</p> <p>Install a coat hook mounted no higher than 48" AFF.<br/>Unit Cost: \$50<br/>Quantity: 1</p> <p>Relocate the grab bar.<br/>Unit Cost: \$50<br/>Quantity: 1</p> | \$300 |

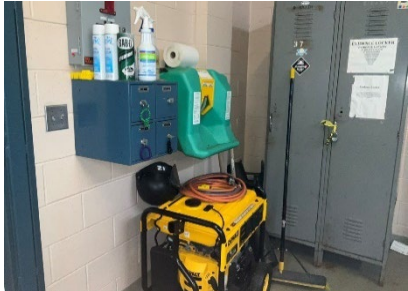
| 9. | <b>Sallyport</b><br>The eye wash control is mounted >44" AFF over a >20"-25" obstruction. | ADAS 308.2.2 | | Lower the eye wash.<br>Unit Cost: \$50 ea.<br>Quantity: 1 | \$50 |

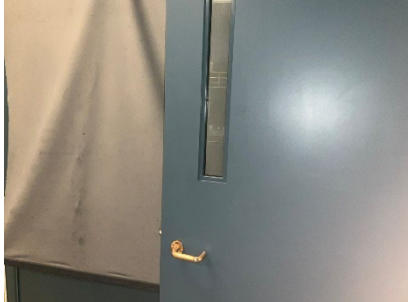
| 10. | <b>Booking</b><br>The pull side door maneuvering clearance is <18" on the latch side, @ 17 3/4".<br><br>The door vision light is mounted >43" AFF, @ 49". | 2010 ADAS 404.2.4.1<br><br>2010 ADAS 404.2.11 | <br> | Install an automatic door opener.<br>Unit Cost: \$2,500 ea.<br>Quantity: 1<br><br>Replace the door leaf with a door with a compliant vision light.<br>Unit Cost: \$1,000<br>Quantity: 1 | \$3,500 |

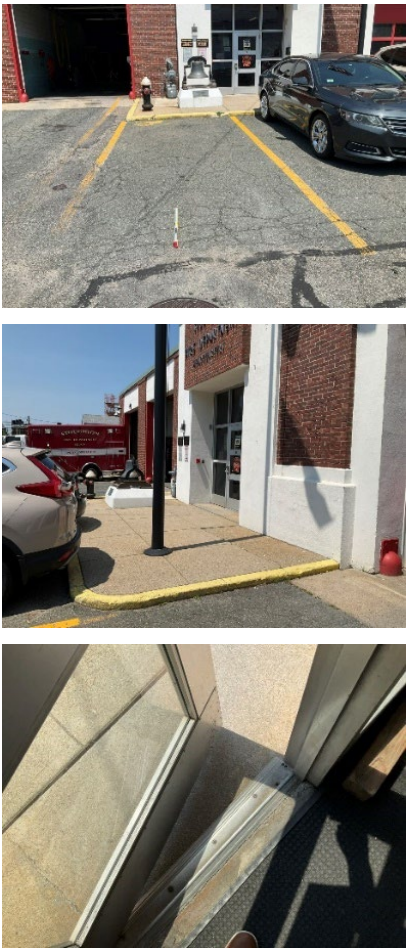
| # | Barrier Statement | Code References | Photo | Proposed Mitigation | Cost |
|---|---|---|---|---|---|
| 1. | <p><b>Entrance</b></p> <p>There is no accessible route into the building as well the apparatus bays, memorial, flagpole, doorbell and emergency phone due to the 4" curb. Further, the walkway between the street and the entrance has running slopes &gt;5%, up to 10%.</p> <p>The exterior threshold measured &gt; 1/2" AFF, @ 1", and not beveled at 1:2.</p> <p>The door lacks a level landing, @ 2.5%, and has a change in level &gt; 1/2" AFF, @ 1", due to the control joint.</p> | <p>2010 ADAS 206</p> <p>2010 ADAS 403.4</p> <p>2010 ADAS 404.2.5</p> <p>2010 ADAS 404.2.4.4</p> | | <p>Provide an accessible route to the building entrance, apparatus bays, memorial, and flagpole. Additional study required.</p> <p>Unit Cost: \$50,000 ea.</p> <p>Quantity: 1</p> | \$50,000 |

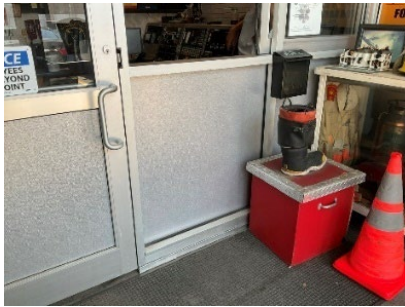
| 2. | <b>Counter</b><br>The counters is >36" AFF, @ 42", and its clear floor space is obstructed by the donation box. | 2010 ADAS 904.4 | | Lower a 36" wide portion of the counter to 36" max. AFF.<br>Unit Cost: \$3,000 ea.<br>Quantity: 1 | \$3,000 |

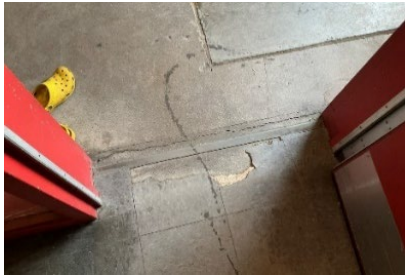
| 3. | <b>Door to Apparatus Bay</b><br>The walkway has abrupt changes of levels >0.5" where two materials meet or due to areas of deterioration/ material settlement. | 2010 ADAS 403.4 | | Modify the transition.<br>Unit cost: \$250<br>Quantity: 1 | \$250 |

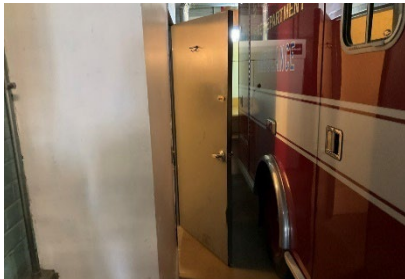
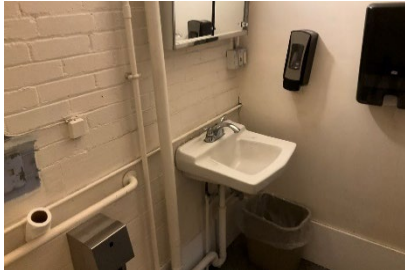
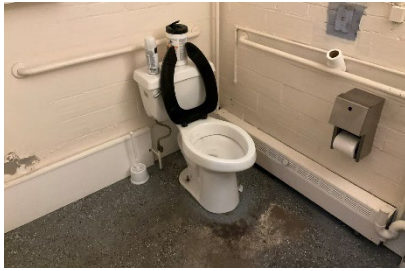
| 4. | <p><b>Single-user Toilet Room inside Apparatus Bay</b></p> <p>There is no tactile/Braille signage mounted on the latch side of the door.</p> <p>The pull side door maneuvering clearance is &lt;42" on the latch side for a hinge side approach, @ obstructed by the fire truck.</p> <p>The sink/lavatory lacks the required 27" high min. knee clearance, @ obstructed by the trash can.</p> <p>Toilet clearance obstructed by the heater and exposed pipes.</p> <p>The coat hook is mounted &gt;48" AFF, @ 72".</p> | <p>2010 ADAS 703.4.2</p> <p>2010 ADAS 404.2.4.1</p> <p>2010 ADAS 306.3.5</p> <p>2010 ADAS 604.3</p> <p>2010 ADAS 604.8.3</p> | | <p>Install tactile/Braille signage on the latch side of the door. Coordinate with location and height requirements.<br/>Unit Cost: \$100 ea.<br/>Quantity: 1</p> <p>Relocate the fire truck. Additional study required.<br/>Unit Cost: \$1,000 ea.<br/>Quantity: 1</p> <p>Relocate the trash can.<br/>Unit Cost: \$50 ea.<br/>Quantity: 1</p> <p>Install insulation around the sink pipes.<br/>Unit Cost: \$100<br/>Quantity: 1</p> <p>Modify the heater and exposed pipes.<br/>Unit Cost: \$750 ea.<br/>Quantity: 2</p> <p>Install a coat hook mounted no higher than 48" AFF.<br/>Unit Cost: \$50 ea.<br/>Quantity: 1</p> | 10,000 |

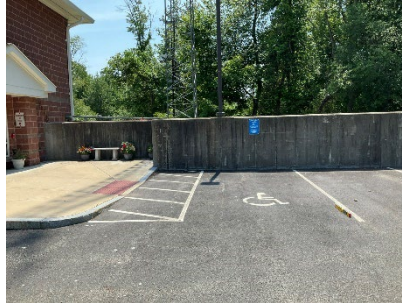
| # | Barrier Statement | Code References | Photo | Proposed Mitigation | Cost |
|---|---|---|---|---|---|
| 1. | <p><b>Parking</b></p> <p>The designated accessible parking signs are mounted &lt;60", @ 42 ½", measured to the bottom of the sign.</p> <p>There is an insufficient number of van accessible parking spaces. The existing accessible parking space does not meet the dimensional requirements for a van space.</p> <p>The designated van accessible access aisle is &lt;96" wide, @ 60", measured centerline to centerline.</p> | <p>2010 ADAS 502.6</p> <p>2010 ADAS 208.2.4</p> <p>2010 ADAS 502.2</p> | | <p>Install signs at 60" min. AFF, measured to the bottom of the sign.<br/>Unit Cost: \$100 ea.<br/>Quantity: 1</p> <p>Restripe a portion of the parking to add the required number of accessible parking spaces, including van spaces, as well as their associated signs and access aisles.<br/>Unit Cost: \$150 ea.<br/>Quantity: 1</p> | \$250 |

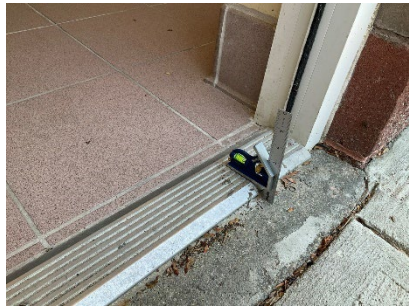
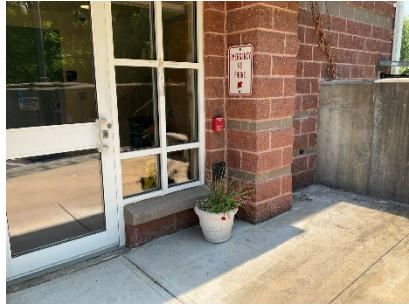
| 2. | <p><b>Entrance</b></p> <p>The threshold is <math>&gt;1/2"</math>, @ <math>1"</math>.</p> <p>The door is located in a recess <math>&gt;8"</math>, @ <math>8.5"</math>.</p> <p>The emergency phone is obstructed by the planter.</p> | <p>2010 ADAS 404.2.5</p> <p>2010 ADAS 404.2.4.3</p> <p>2010 ADAS 308.2.1</p> | | <p>Replace the threshold.<br/>Unit cost: \$250 ea.<br/>Quantity: 1</p> <p>Install an automatic door opener.<br/>Unit Cost: 2,500 ea.<br/>Quantity: 1</p> <p>Relocate the planter.<br/>Unit Cost: \$150 ea.<br/>Quantity: 1</p> | \$2,900 |

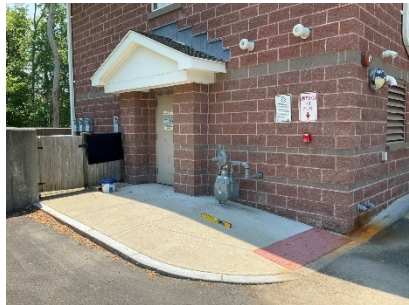
| 3. | <p><b>Rear Exit</b></p> <p>The running slope of the curb ramp is <math>&gt;8.3\%</math>, @ <math>10.2\%</math>.</p> <p>The emergency phone is not located on an accessible route due to its placement along the ramp and is mounted <math>&gt;48"</math> AFF, @ <math>53"</math>.</p> | <p>2010 ADAS 405.2</p> <p>2010 ADAS 206.1</p> <p>2010 ADAS 308.2.1</p> | | <p>Rebuild the curb ramp.<br/>Unit cost: \$1,250 ea.<br/>Quantity: 1</p> <p>Relocate the emergency phone.<br/>Unit Cost: \$150 ea.<br/>Quantity: 1</p> | \$1,400 |

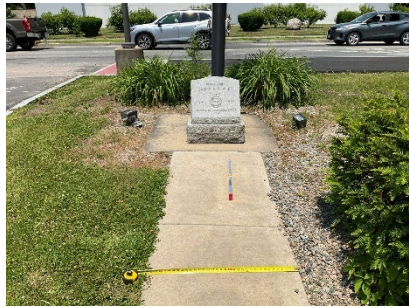
| 4. | <b>Memorial and Flagpole</b><br>The walkway to the memorial and the flagpole has running slopes >5%, @ 5.2%<br>The rope hook is obstructed by the memorial. | 2010 ADAS 403.3<br>2010 ADAS 308.2 | | Regrade the walkway and reconfigure the memorial and flagpole. Additional study required.<br>Unit Cost: \$5,000 ea.<br>Quantity: 1 | \$5,000 |

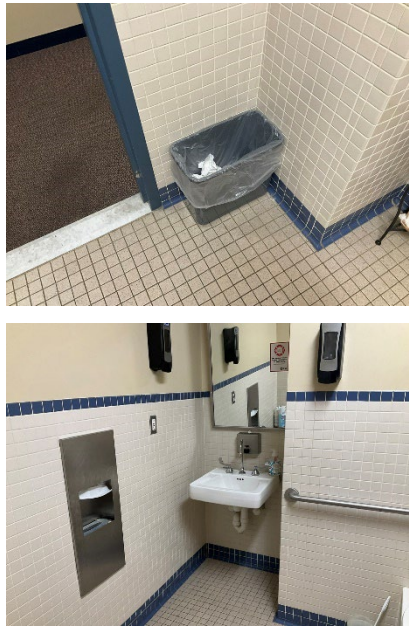
| 6. | <p><b>Men's Toilet Room</b></p> <p>The pull side maneuvering clearance at the door is &lt;18", @ obstructed by the trash can.</p> <p>The bottom of the reflective surface of the mirror is &gt;40" AFF, @ 46 1/2".</p> <p>The soap dispenser is &gt;48" AFF, @ 62".</p> | <p>2010 ADAS 404.2.4.1</p> <p>2010 ADA 603.3</p> <p>2010 AAS 308.2.1</p> | | <p>Relocate the trash can.<br/>Unit Cost \$50 ea.<br/>Quantity: 1</p> <p>Lower the mirror.<br/>Unit Cost: \$50<br/>Quantity: 1</p> <p>Relocate the dispenser.<br/>Unit Cost: \$50<br/>Quantity: 1</p> | \$150 |

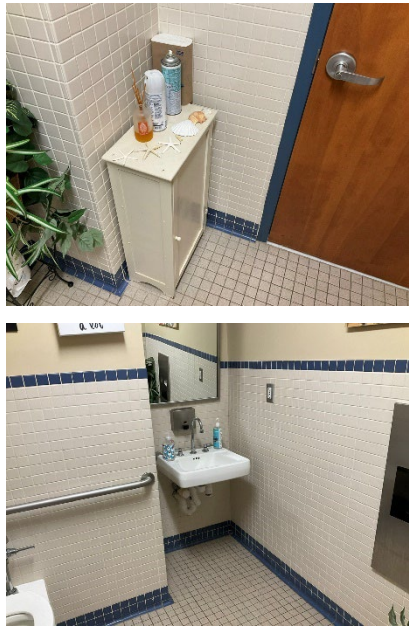
| 7. | <b>Women's Toilet Room</b><br><p>The pull side maneuvering clearance at the door is &lt;18", @ obstructed by the cabinet.</p> <p>The bottom of the reflective surface of the mirror is &gt;40" AFF, @ 57 1/4".</p> <p>The soap dispenser is &gt;48" AFF, @ 62".</p> <p>The toilet lacks the required clearance around it, @ due to the chair.</p> | <p>2010 ADAS 404.2.4.1</p> <p>2010 ADA 603.3</p> <p>2010 AAS 604.3</p> | | <p>Relocate the trash can.<br/>Unit Cost \$50 ea.<br/>Quantity: 1</p> <p>Lower the mirror.<br/>Unit Cost: \$50<br/>Quantity: 1</p> <p>Relocate the chair.<br/>Unit Cost: \$50<br/>Quantity: 1</p> | \$150 |

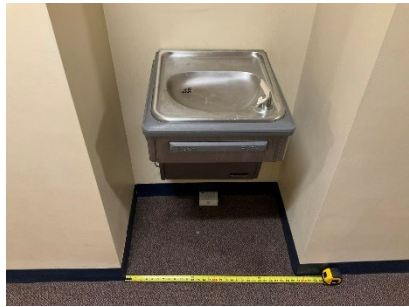
| 8. | <b>Drinking Fountain</b><br><p>A drinking fountain for standing persons is not provided.</p> | 200 ADAS 211.2 | | <p>Install a high drinking fountain.<br/>Unit Cost: \$1,500 ea.<br/>Quantity: 1</p> | \$1,500 |

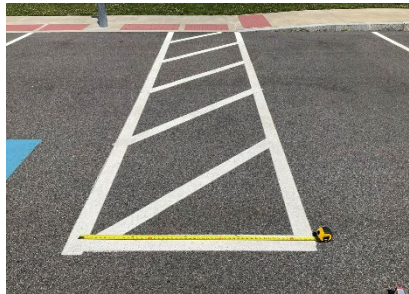
| # | Barrier Statement | Code References | Photo | Proposed Mitigation | Cost |
|---|---|---|---|---|---|
| 2. | <b>Parking (Side)</b><br>The access aisle is <60" wide, measured centerline to centerline, @ 51". | 2010 ADAS 502.3.1 | | Restripe the pavement markings in the parking spaces and associated access aisles.<br>Unit Cost: \$150 ea.<br>Quantity: 1 | \$150 |

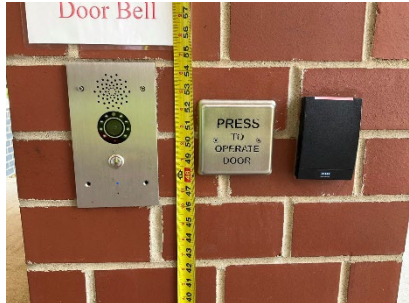
| # | Barrier Statement | Code References | Photo | Proposed Mitigation | Cost |
|---|---|---|---|---|---|
| 3. | <b>Front Entrance</b><br>The intercom is mounted >48" AFF, @ 49".<br><br>The push button of the automatic door opener is mounted >48" AFF, @ 50". | 2010 ADAS 308.2.1 | | Relocate the intercom and the push button.<br>Unit Cost: \$150 ea.<br>Quantity: 2 | \$300 |

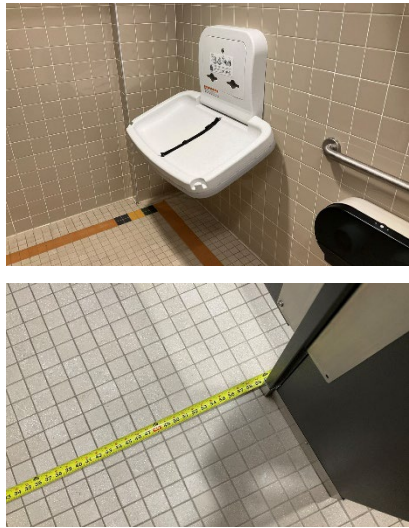
| 5. | <b>Men's Toilet Room</b><br><p>The entry door requires &gt;5lbs of force to operate.</p> <p>The baby changing station is malfunctioning.</p> <p>The accessible toilet stall is &lt;60" wide, @ 59", near the stall door due to the uneven partition.</p> <p>There is no pull device on the push side of the door.</p> <p>The stall door is not self-closing.</p> | <p>2010 ADAS 404.2.9</p> <p>ADA Title II Maintenance</p> <p>2010 ADAS 604.3.1</p> <p>2010 ADAS 604.8.1.1</p> <p>2010 ADAS 604.8.1.2</p> | | <p>Adjust the door closer.<br/>Unit Cost: \$50 ea.<br/>Quantity: 1</p> <p>Replace the baby changing station.<br/>Unit Cost: \$50 ea.<br/>Quantity: 1</p> <p>Relocate the stall partition.<br/>Unit Cost: \$900 ea.<br/>Quantity: 1</p> <p>Install a pull device on the door.<br/>Unit Cost: \$250 ea.<br/>Quantity: 1</p> <p>Install a self-closing door.<br/>Unit Cost: \$150<br/>Quantity: 1</p> | \$1,400 |
