## STOUGHTON OUTDOOR FACILITIES AUDITS

*KMA audited the following municipal outdoor facilities:*

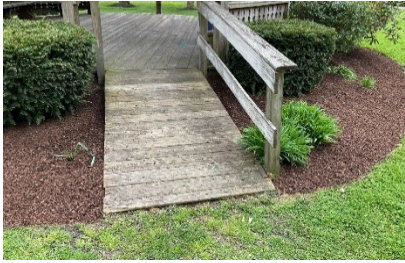
| 4. | <b>Gazebo</b><br>The gazebo is not on an accessible route, due to the grass surface.<br>The ramp to the gazebo has running slopes >8.3%, @ up to 8.9%, and has changes in level > ¼" at the bottom of the run, @ 1".<br>The stair to the gazebo lacks the required handrails on both sides. | 2010 ADAS 206.1<br>2010 ADAS 405.2<br>2010 ADAS 303.2<br>2010 ADAS 505.2 | <br> | Provide an accessible route between the sidewalk and the gazebo.<br>Unit Cost: \$25/SF<br>Est. Quantity: 600 SF<br>Rebuild the ramp.<br>Unit Cost: \$5,000 ea.<br>Quantity: 1<br>Install compliant handrails on both sides of the stairs.<br>Unit Cost: \$50/LF<br>Est. Quantity: 8 | \$20,400 |

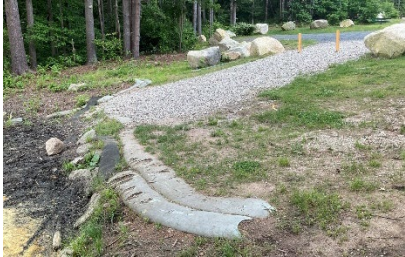
| 7. | <b>Boat Launch Ramp</b><br>An accessible boat launch ramp is not provided. | 2010 ADAS 206.2.10 | | Provide an accessible boat launch ramp.<br>Unit Cost: \$25/SF<br>Est. Quantity: 1,000 SF | \$25,000 |

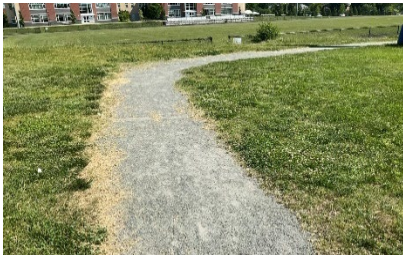
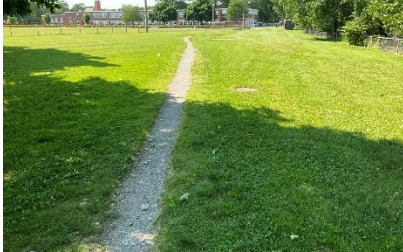
| 1. | <p><b>Walkways</b></p> <p>The walkway that loops around the complex and along Levitz Playground is not accessible due to the gravel and stone dust surface.</p> <p>Further, the walkway is &lt;36" wide in certain areas along the East side of the complex.</p> | 2010 ADAS 206.1 | | <p>Provide an accessible route throughout the complex.</p> <p>Unit Cost: \$25/SF</p> <p>Est. Quantity: 2,800 SF</p> | \$70,000 |
